**INTERNATIONAL PHASE OF OCEAN DRILLING (IPOD)  
DEEP SEA DRILLING PROJECT  
DEVELOPMENT ENGINEERING  
TECHNICAL REPORT NO. 14**

## **DRILL STRING FAILURE ANALYSES**

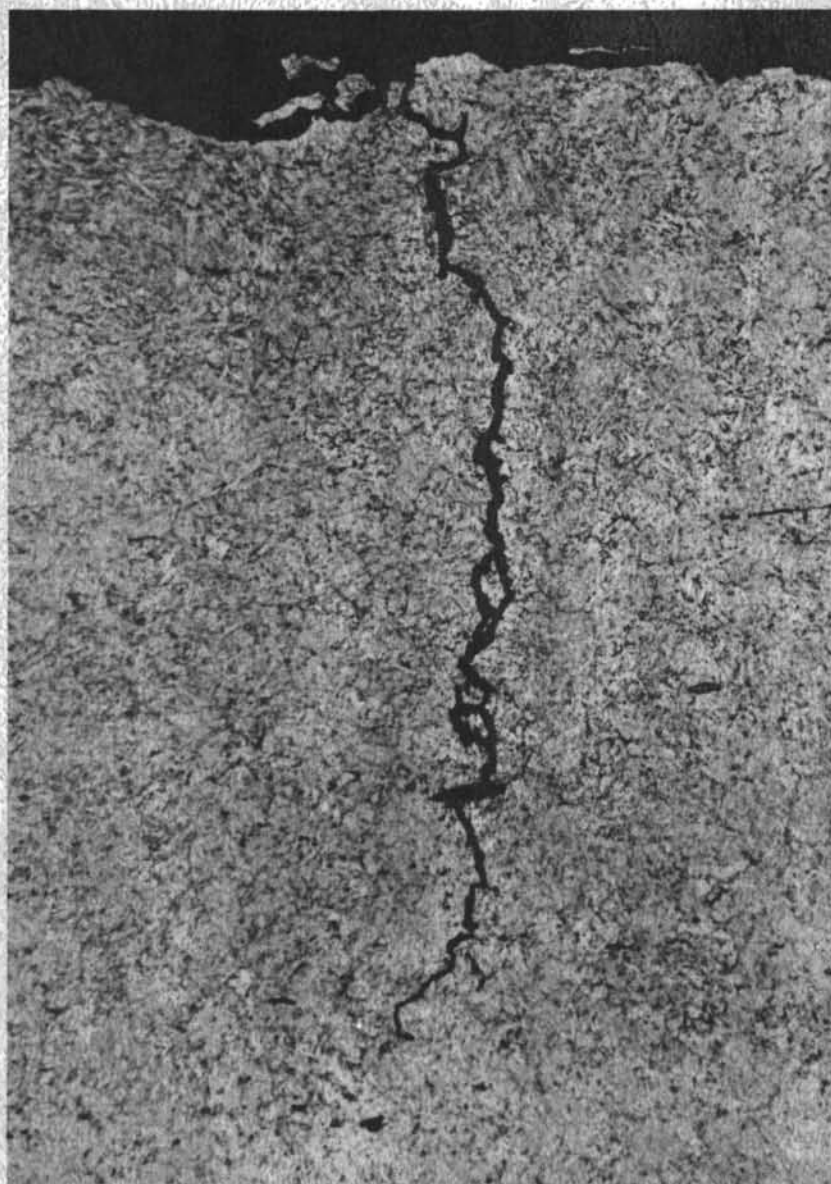
**SCRIPPS INSTITUTION OF OCEANOGRAPHY  
UNIVERSITY OF CALIFORNIA AT SAN DIEGO  
CONTRACT NSF C-482  
PRIME CONTRACTOR: THE REGENTS, UNIVERSITY OF CALIFORNIA**

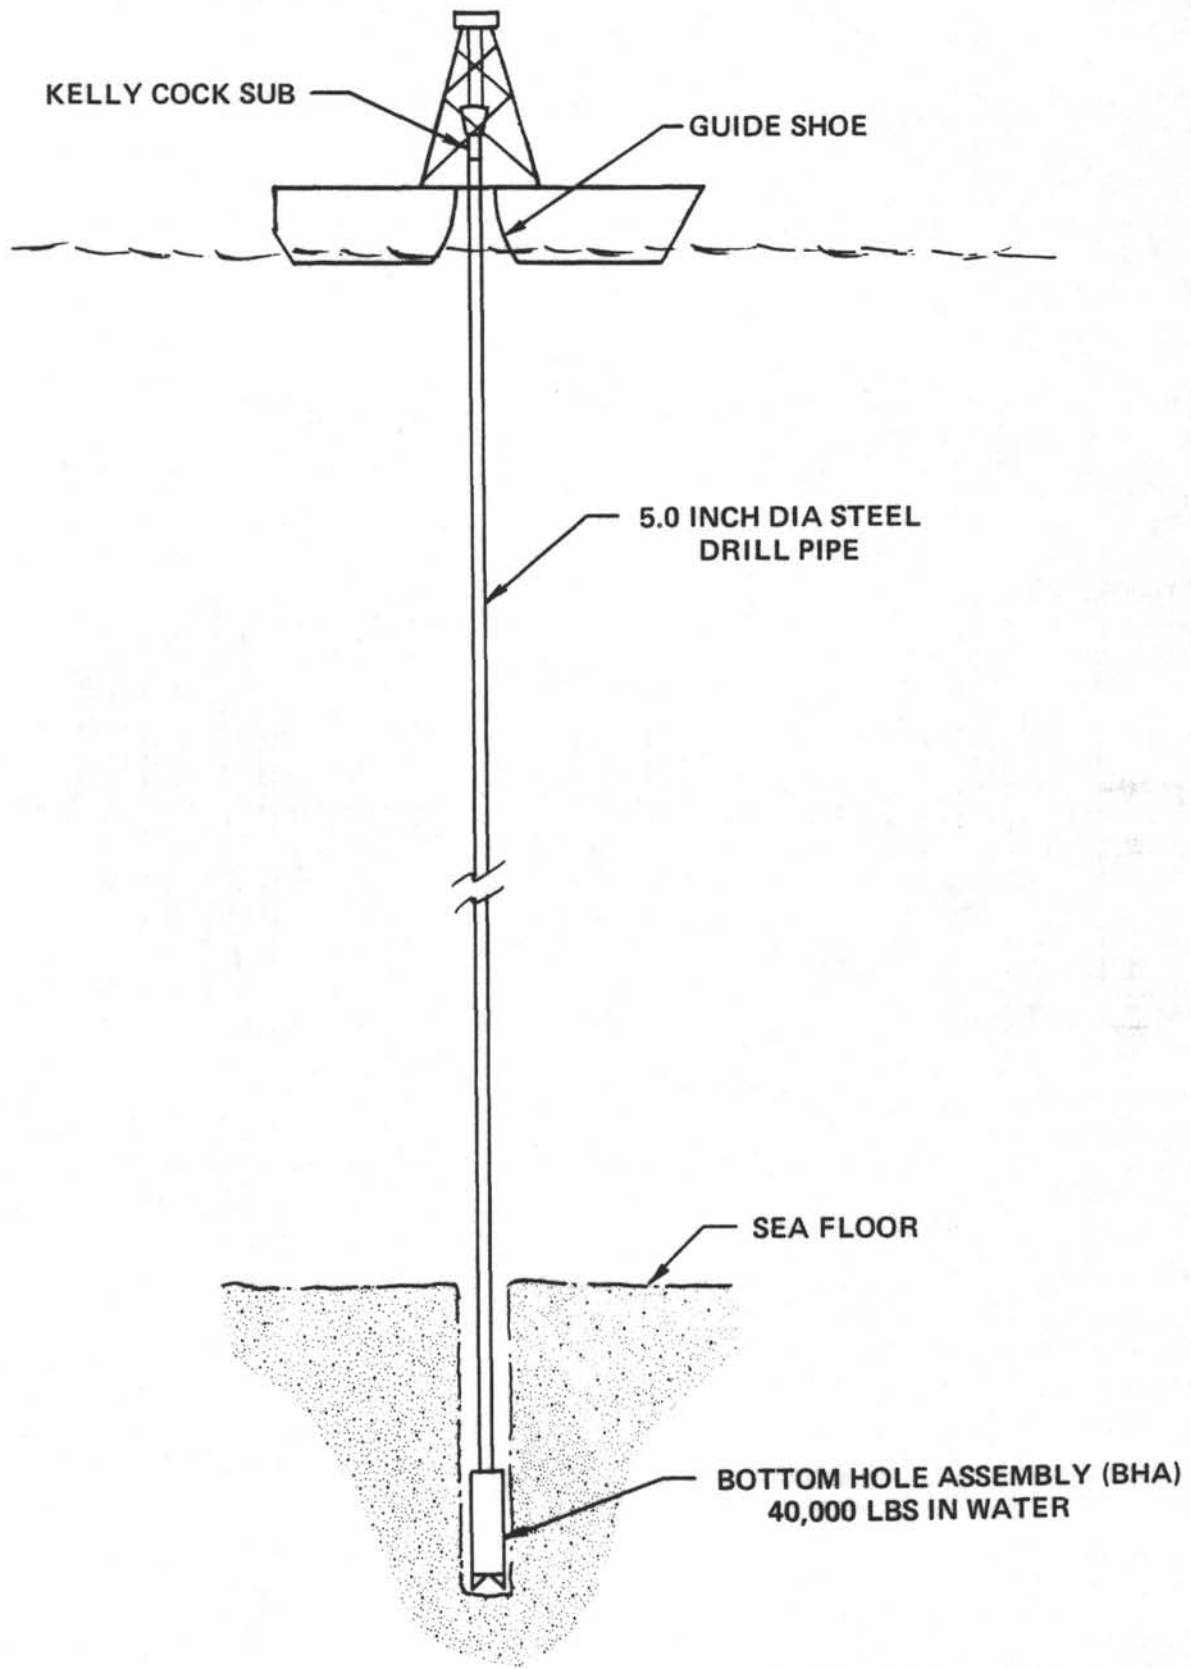
CONFIGURATION OF DRILL STRING  
FIGURE 1

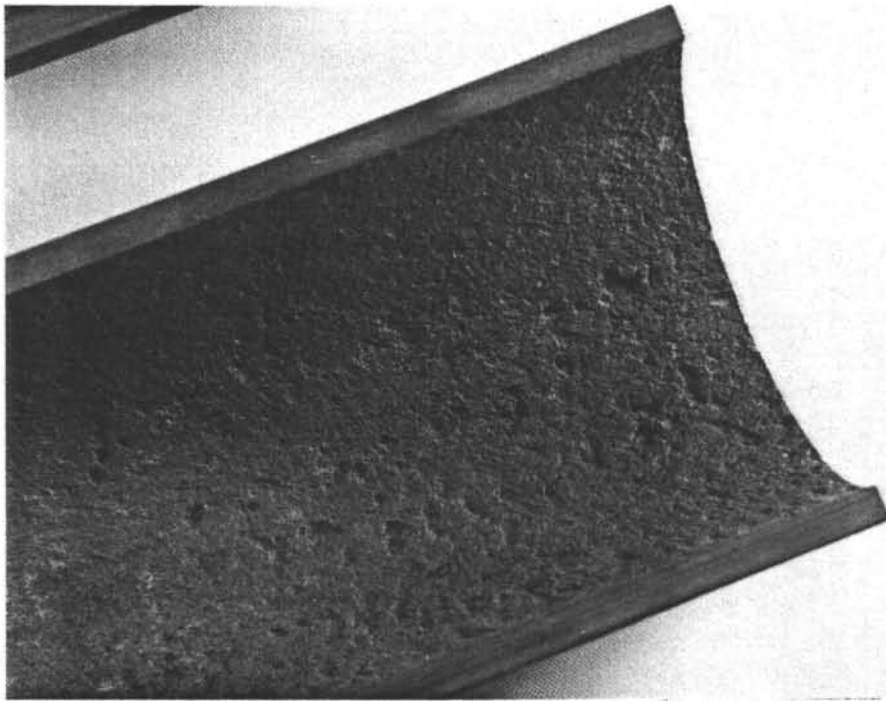
**CORROSION ON INTERIOR SURFACE OF DRILL PIPE  
FIGURE 3**

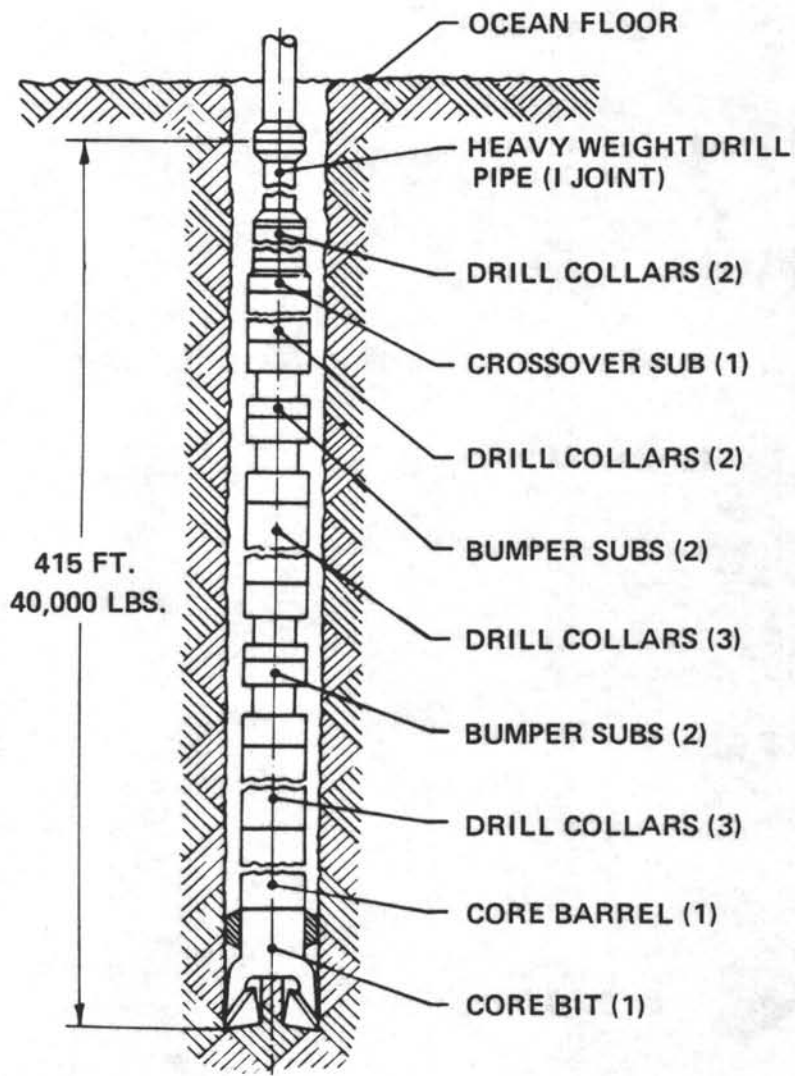
TYPICAL BOTTOM HOLE ASSEMBLY (BHA)  
FIGURE 4

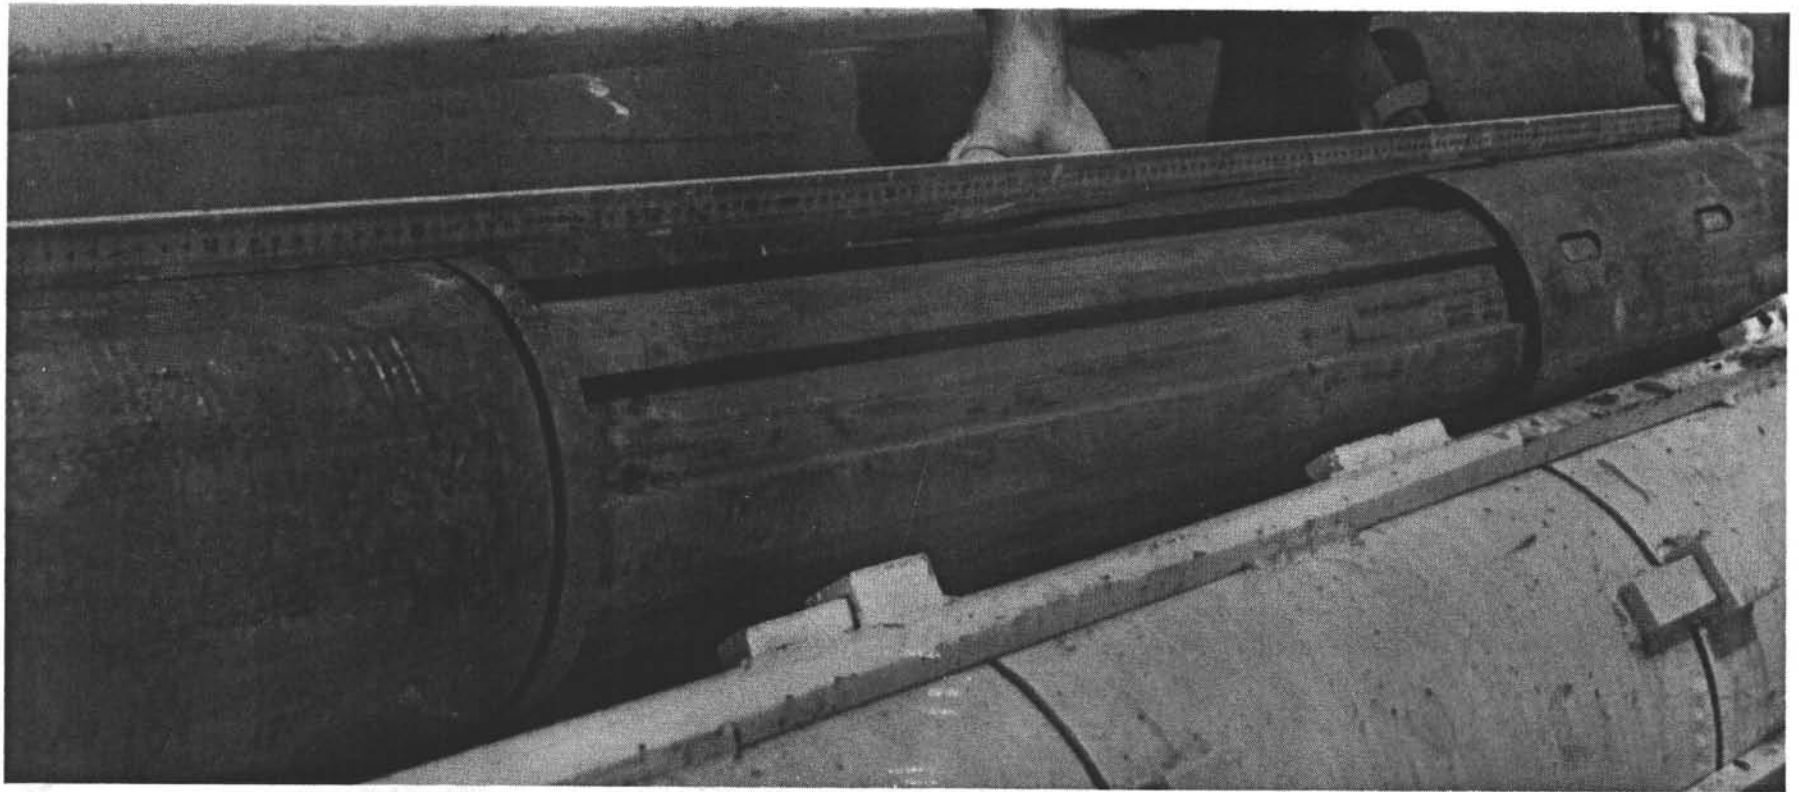
**BUMPER SUB IN FULLY STROKED OUT CONDITION  
FIGURE 5**

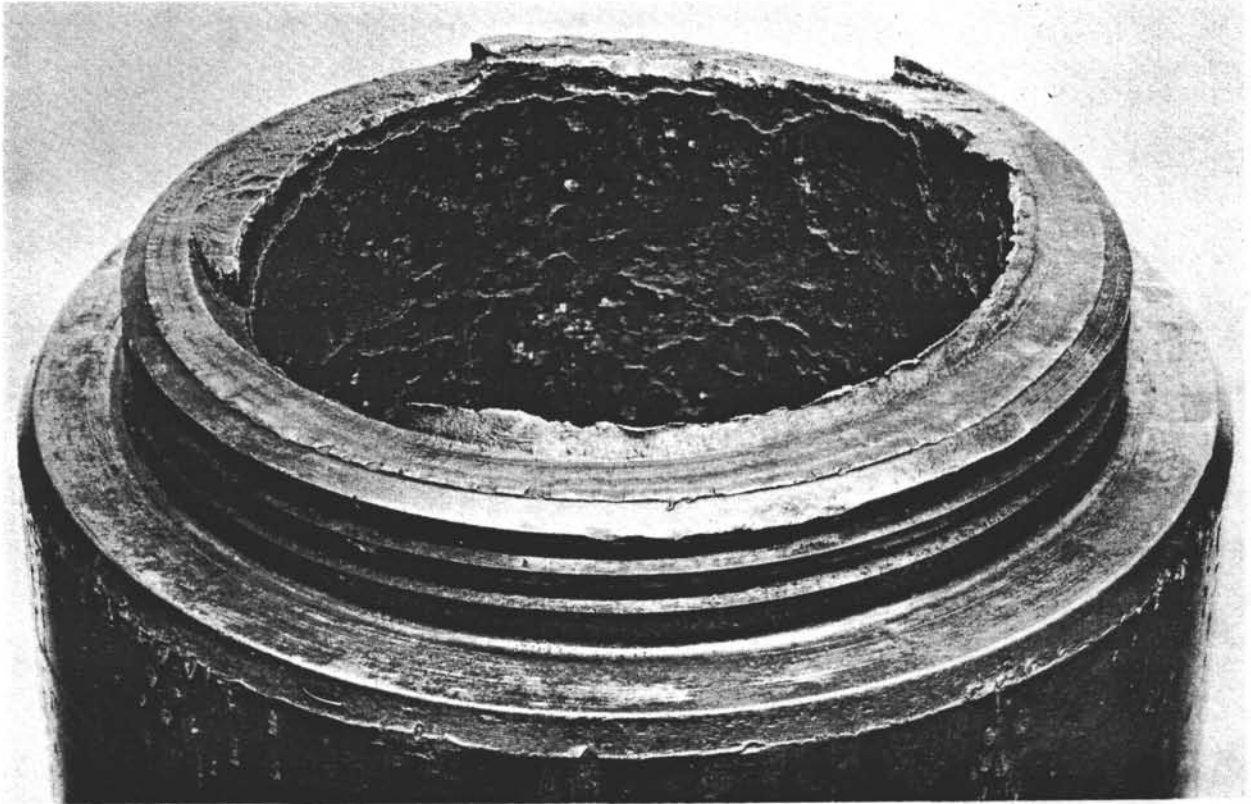
Tool joint B (Figure 2) that had fractured in the threads. Note the heavy layer of rust on the inside surface. Approximately actual size.

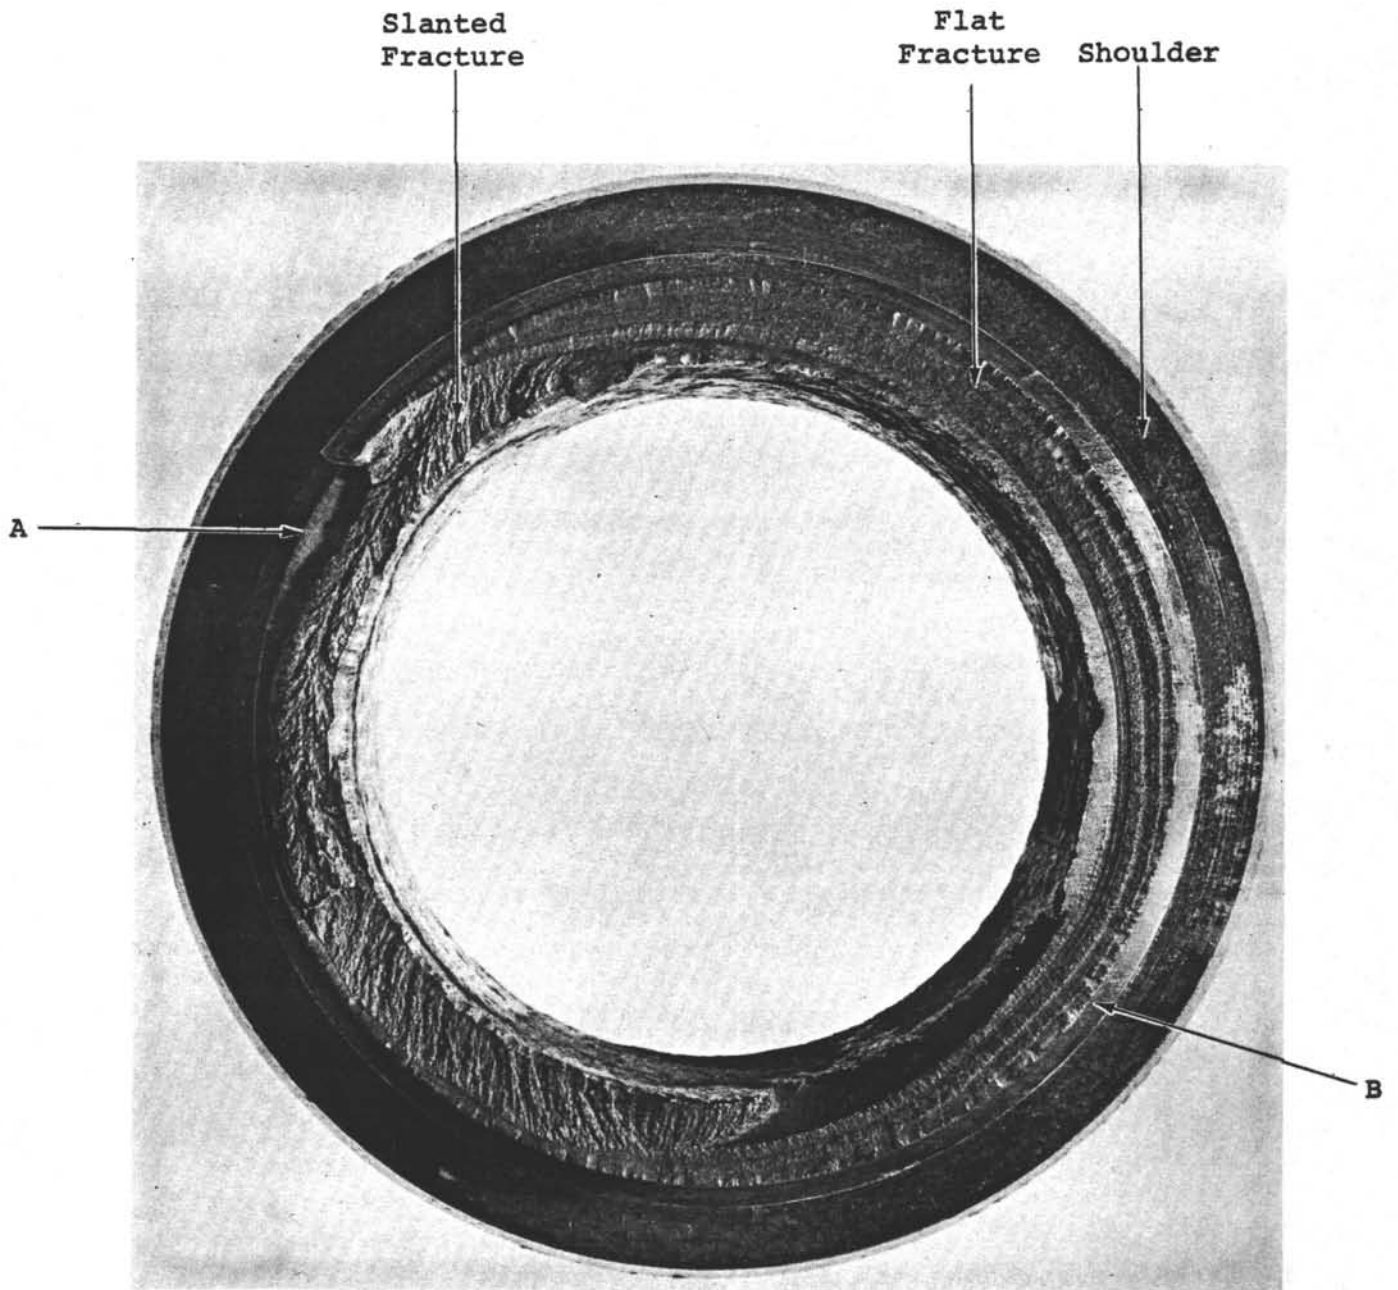
Fracture surface of tool joint B. Approximately actual size.

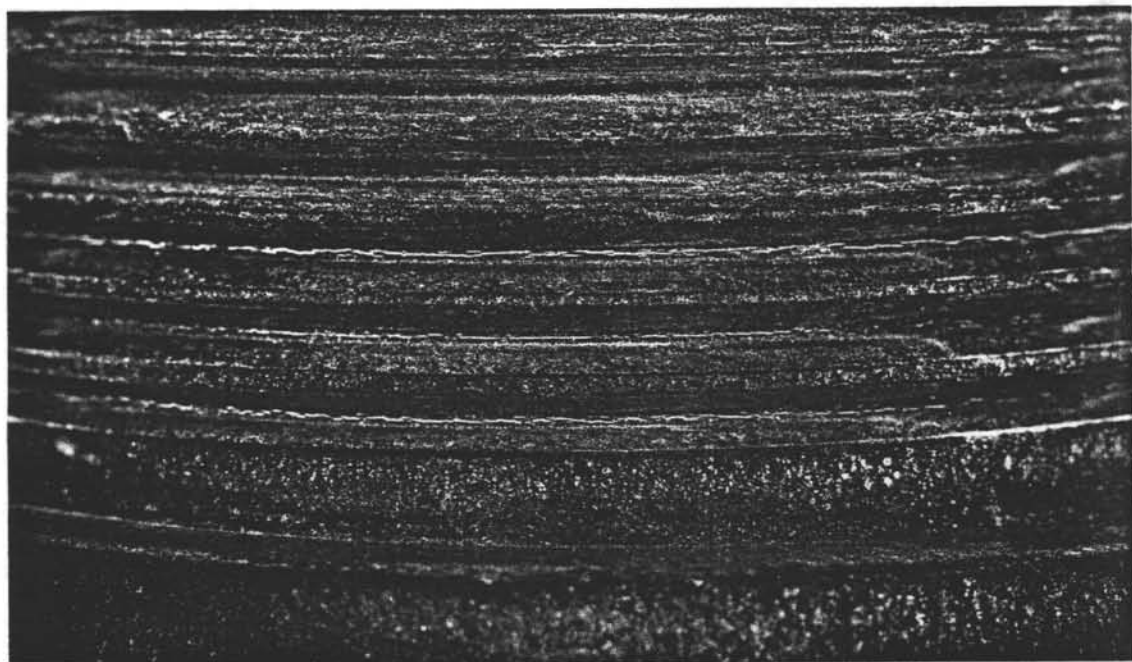
Cracks in thread roots of tool joint A (as indicated by disconnected white lines in thread roots). Cracks were revealed by fluorescent magnetic particle technique with ultraviolet illumination. X2.

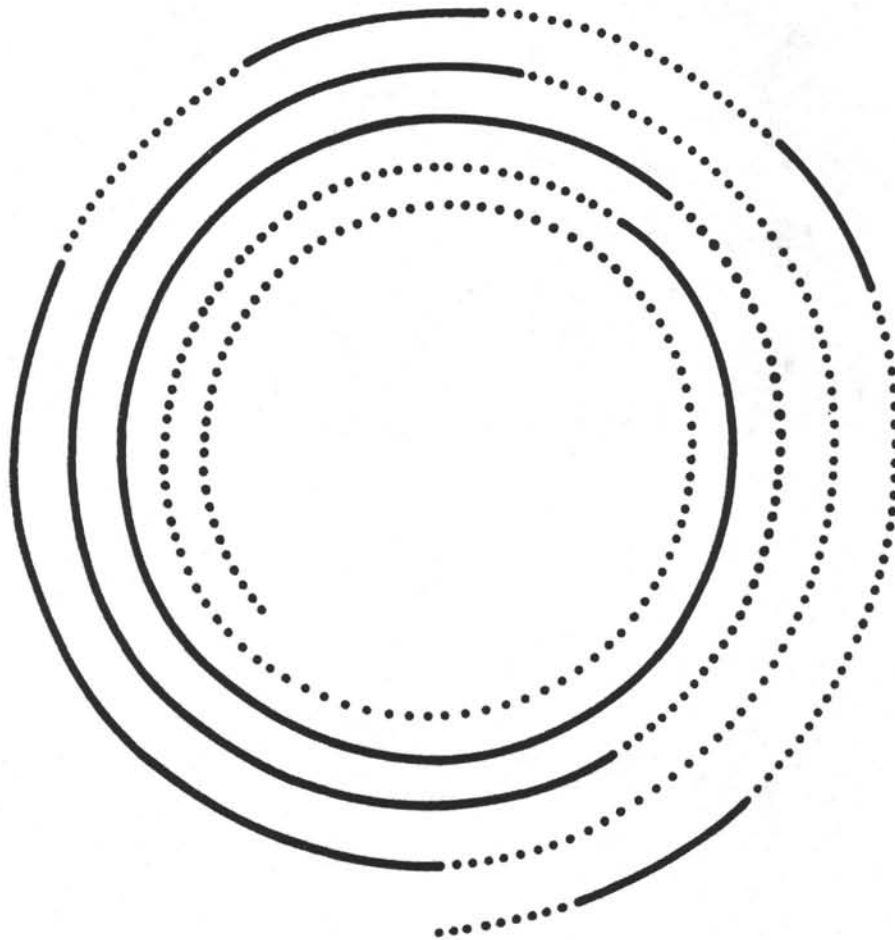
————— CRACKED  
..... NOT CRACKED

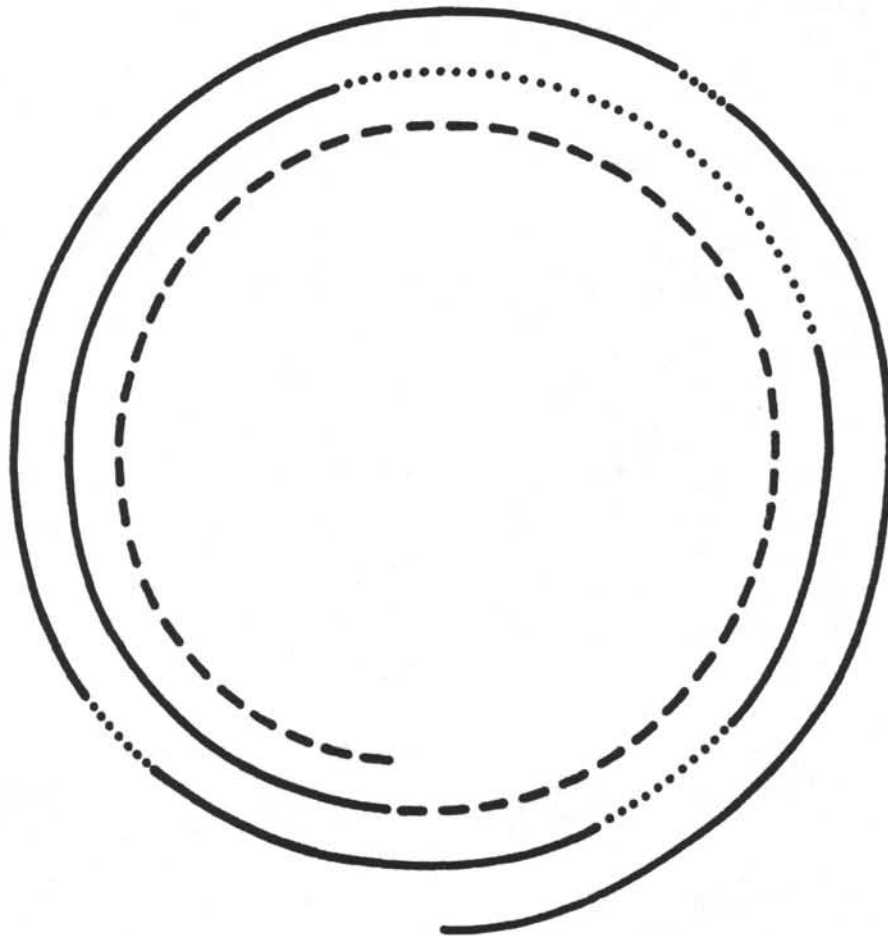
----- FRACTURE  
————— CRACKED  
..... NOT CRACKED

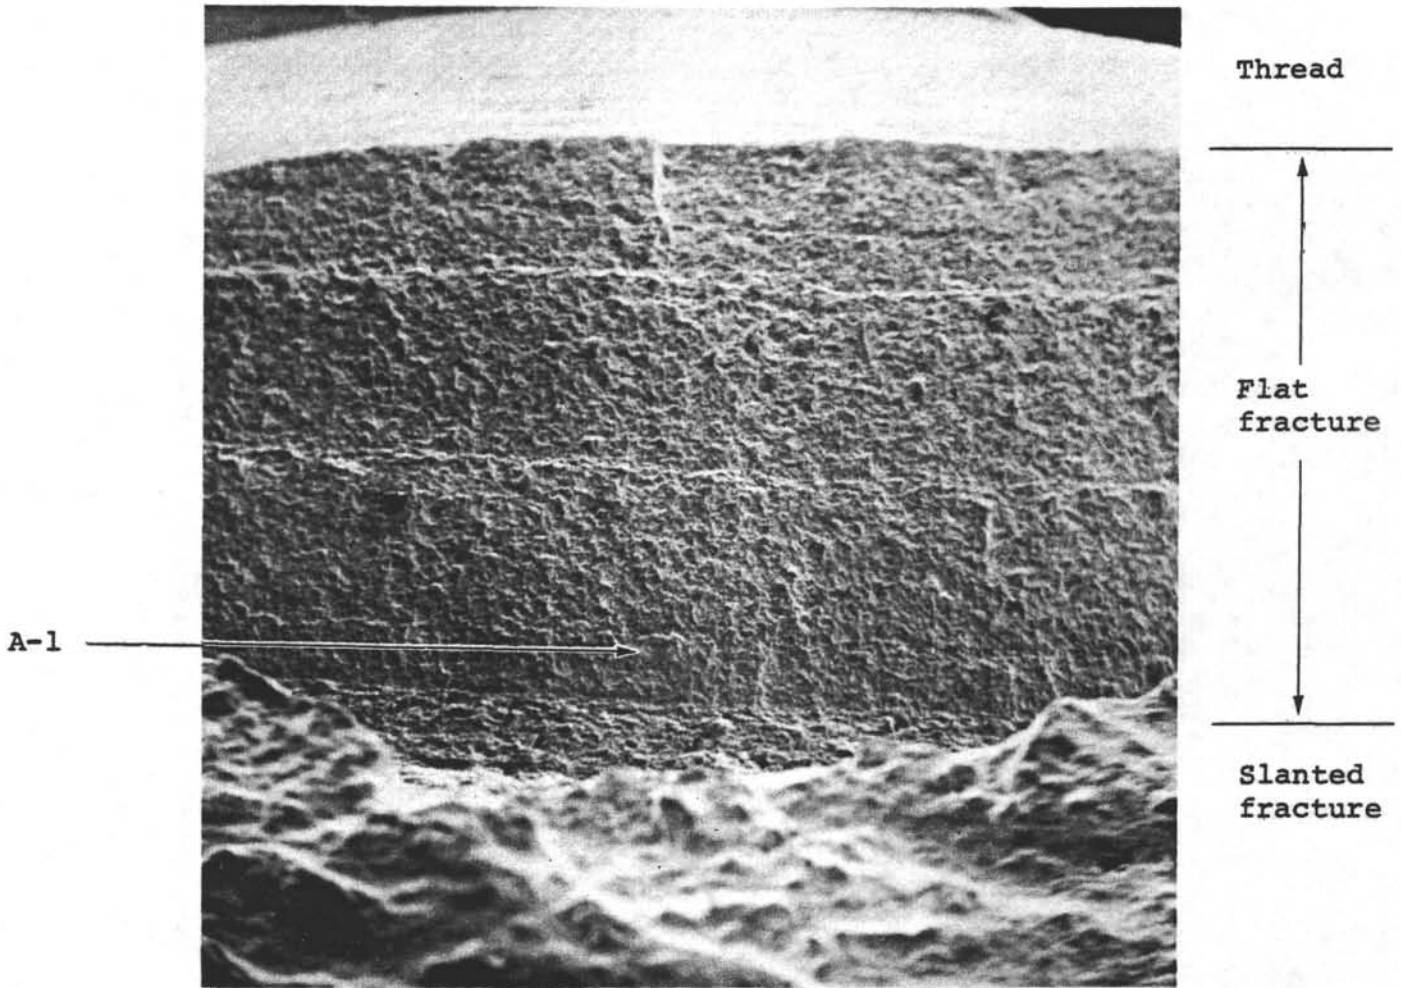
Surface of flat fracture zone in Area A, Figure 4. X25.

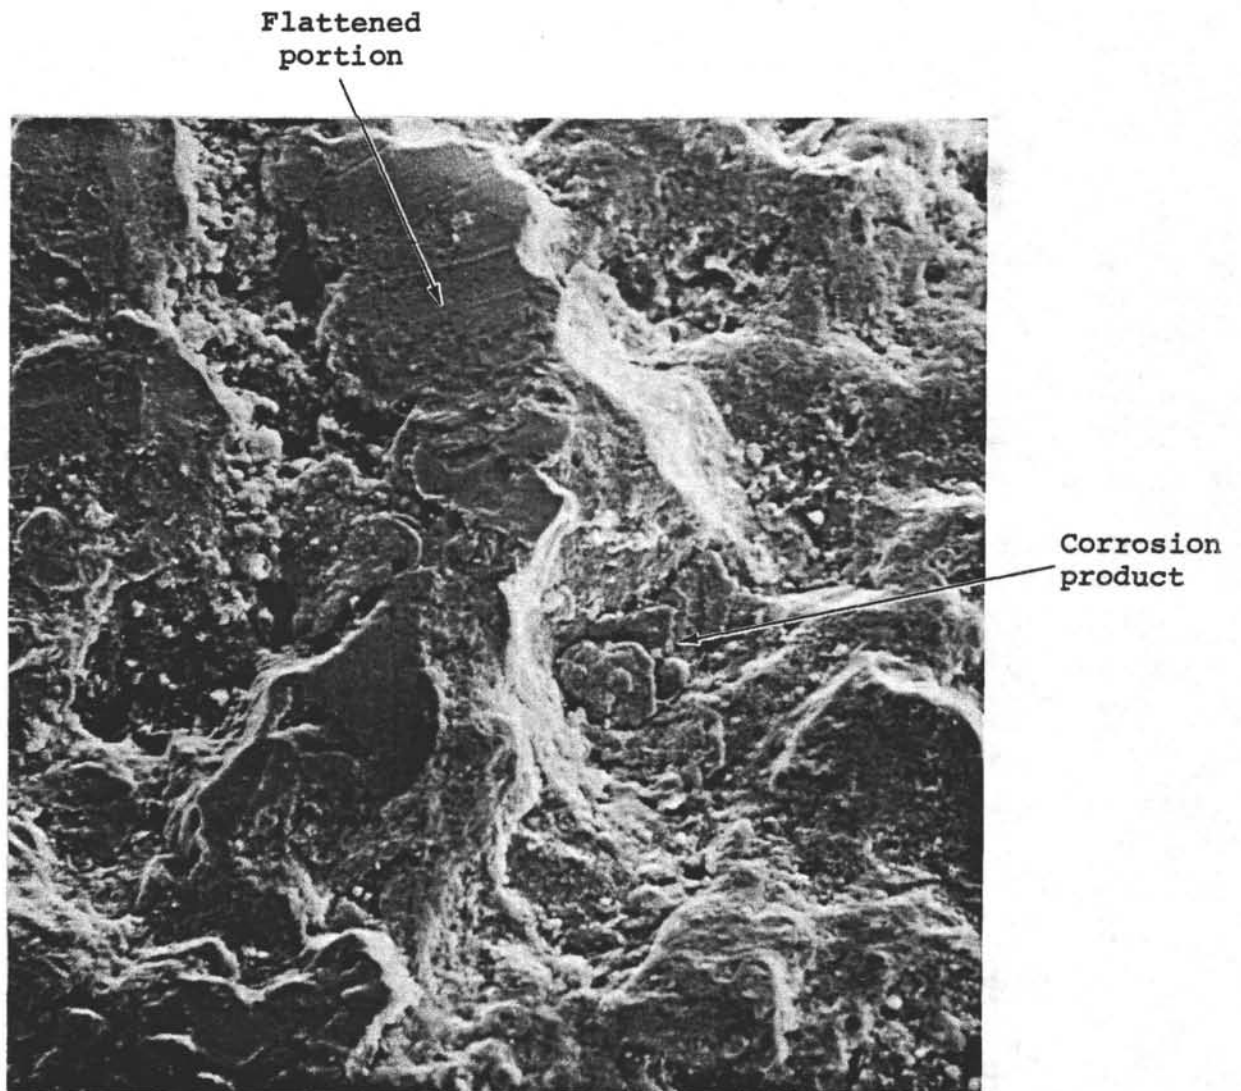
Surface of flat fracture zone in Area A-1, Figure 9, showing flattened raised portions and corrosion product in low portions. X1000.

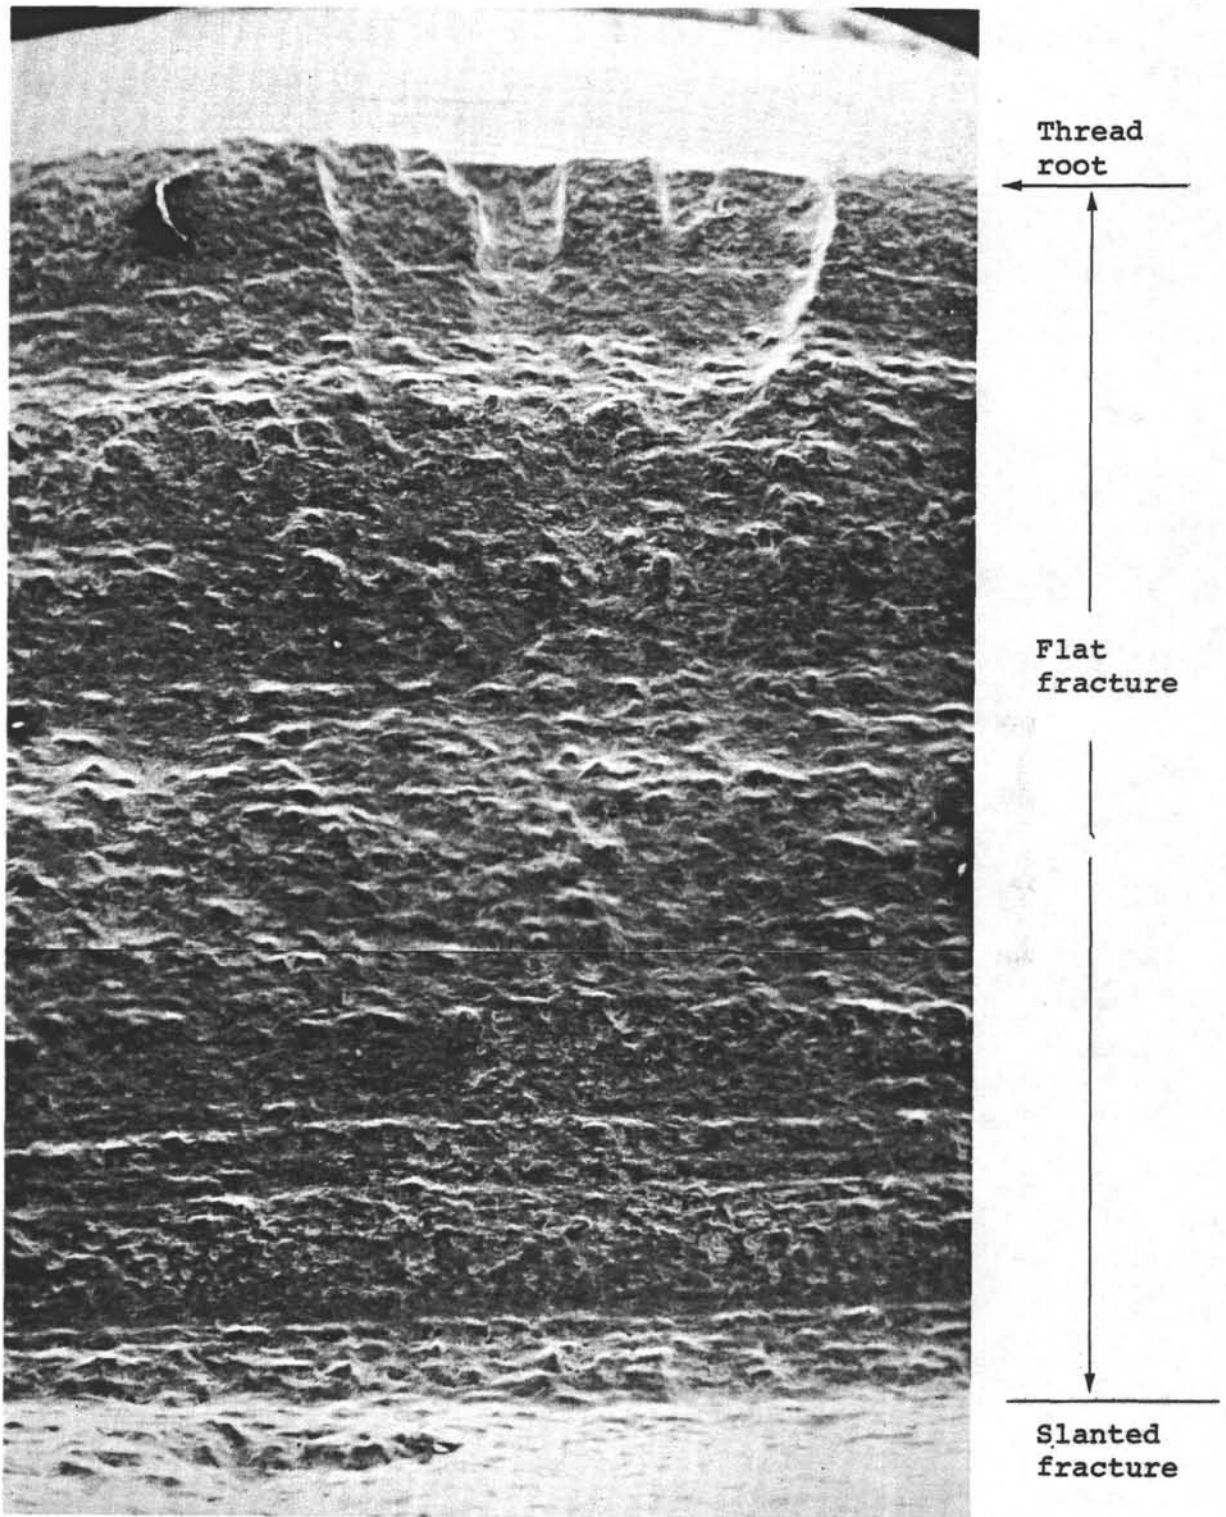
Surface of flat fracture zone in Area B, Figure 4. X25.

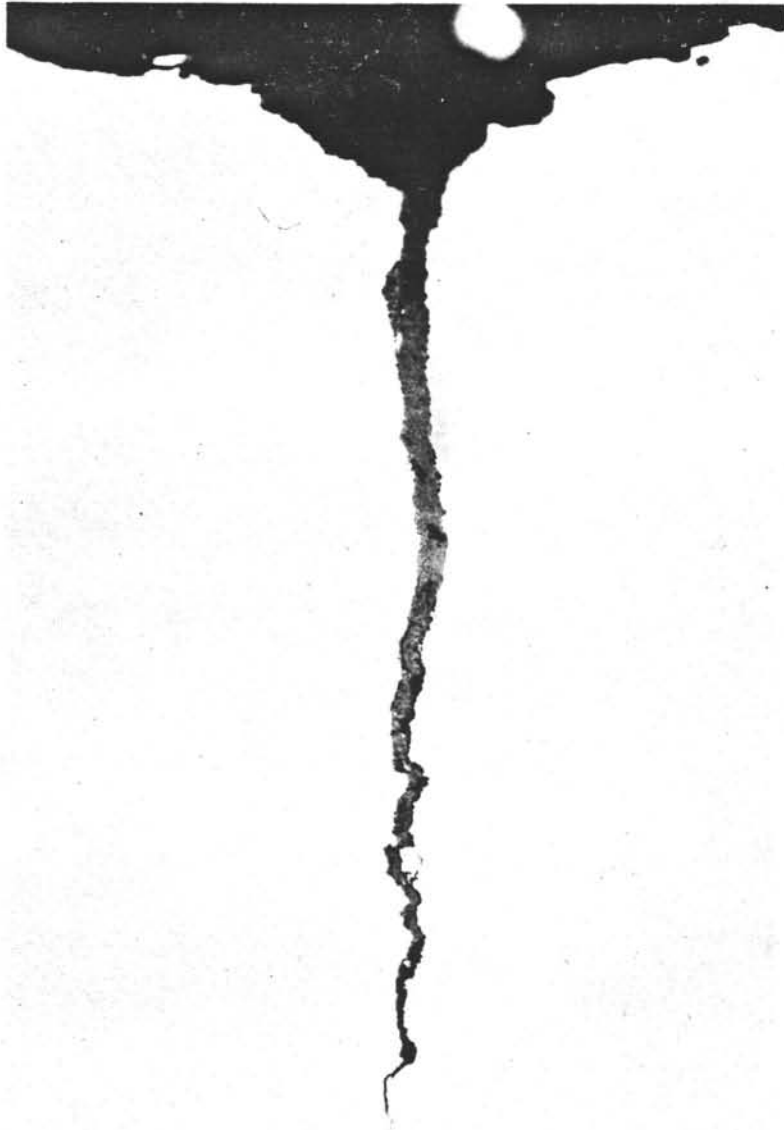
Crack emanating from a corrosion pit in the thread root of tool joint B. Unetched. X500.

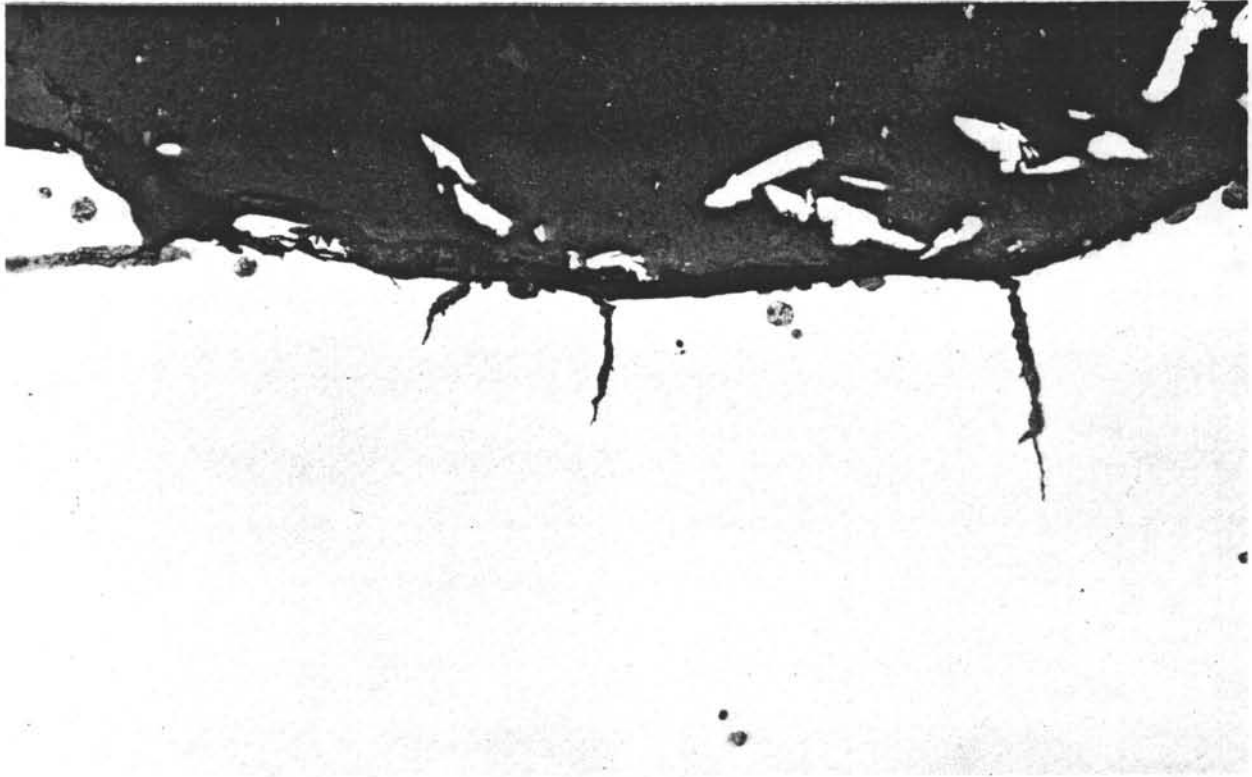
Multiple crack initiation in a thread root of tool joint A. Unetched. X250.

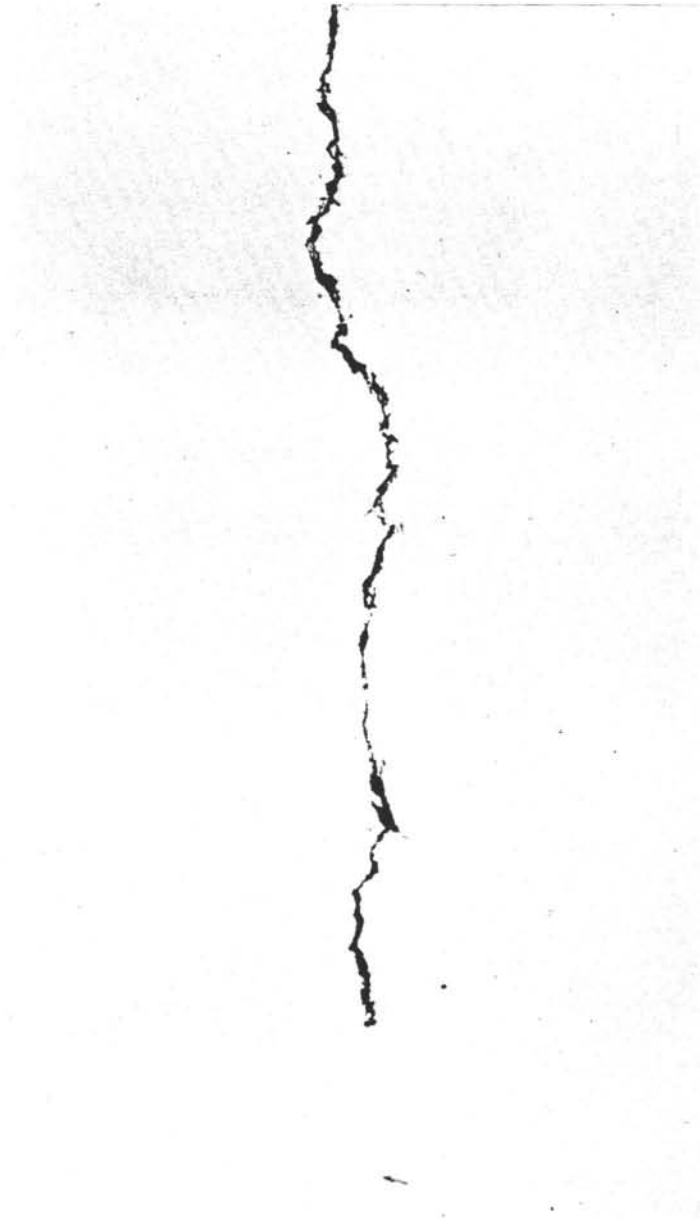
Typical crack in tool joint B. Unetched. X500.

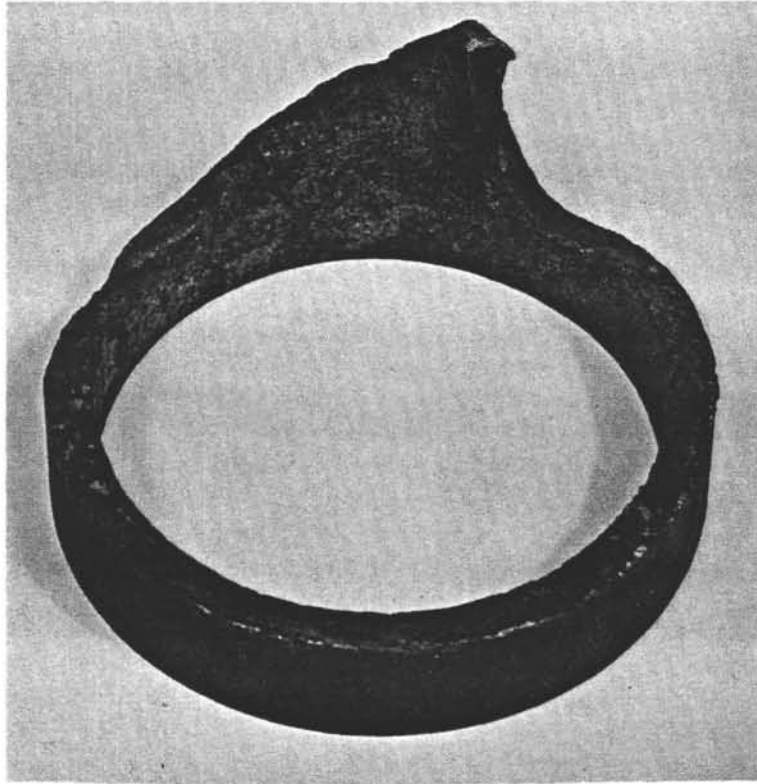
Fractured end of Sample A. Note flat portion at bottom of photograph. About 0.6 actual size.

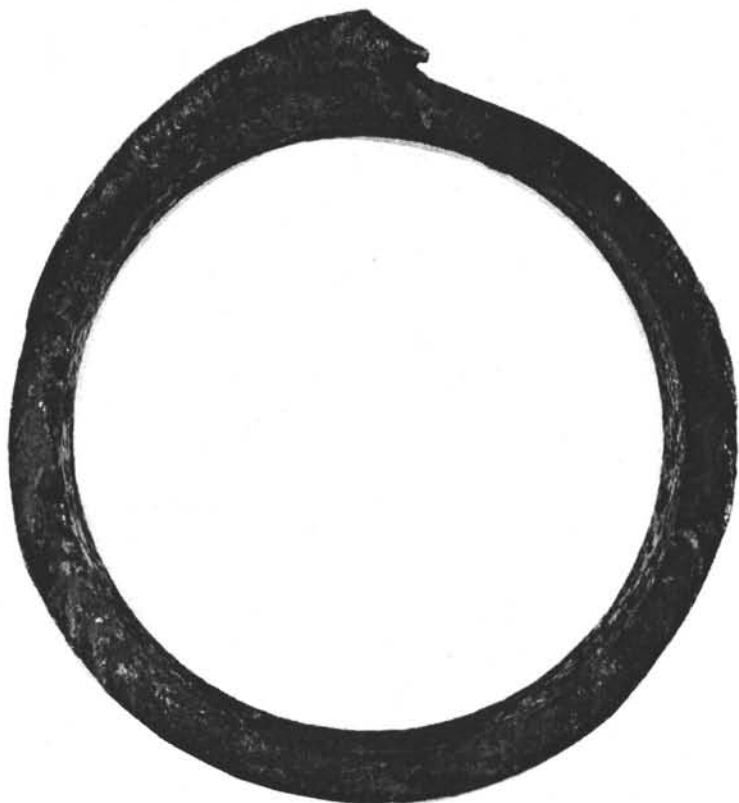
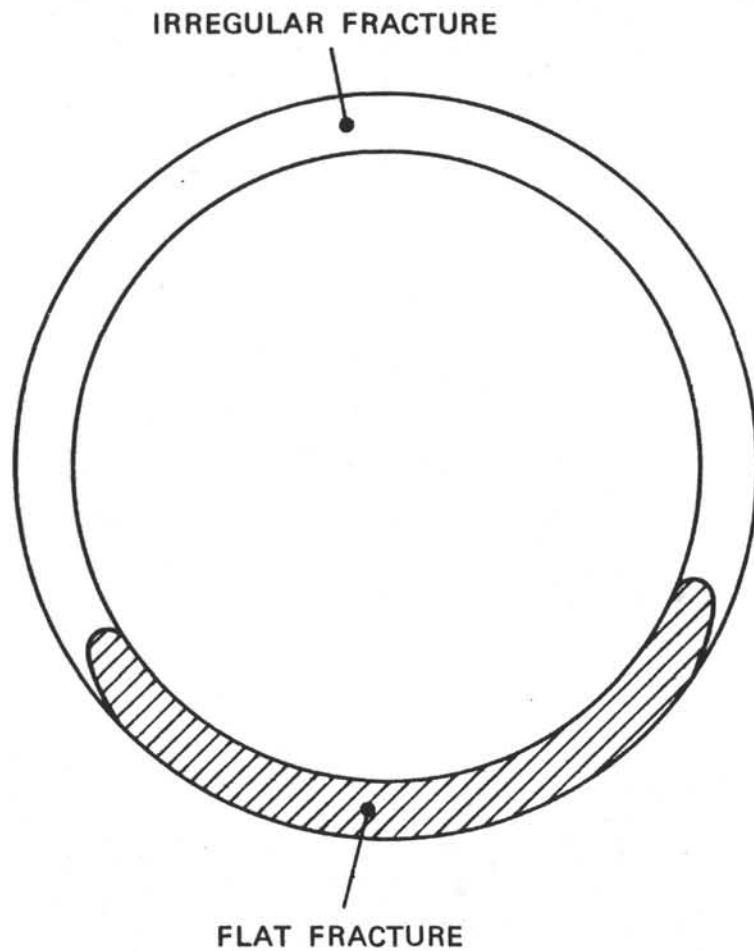
FRACTURE SURFACE OF SAMPLE A. ABOUT 0.7 ACTUAL SIZE.

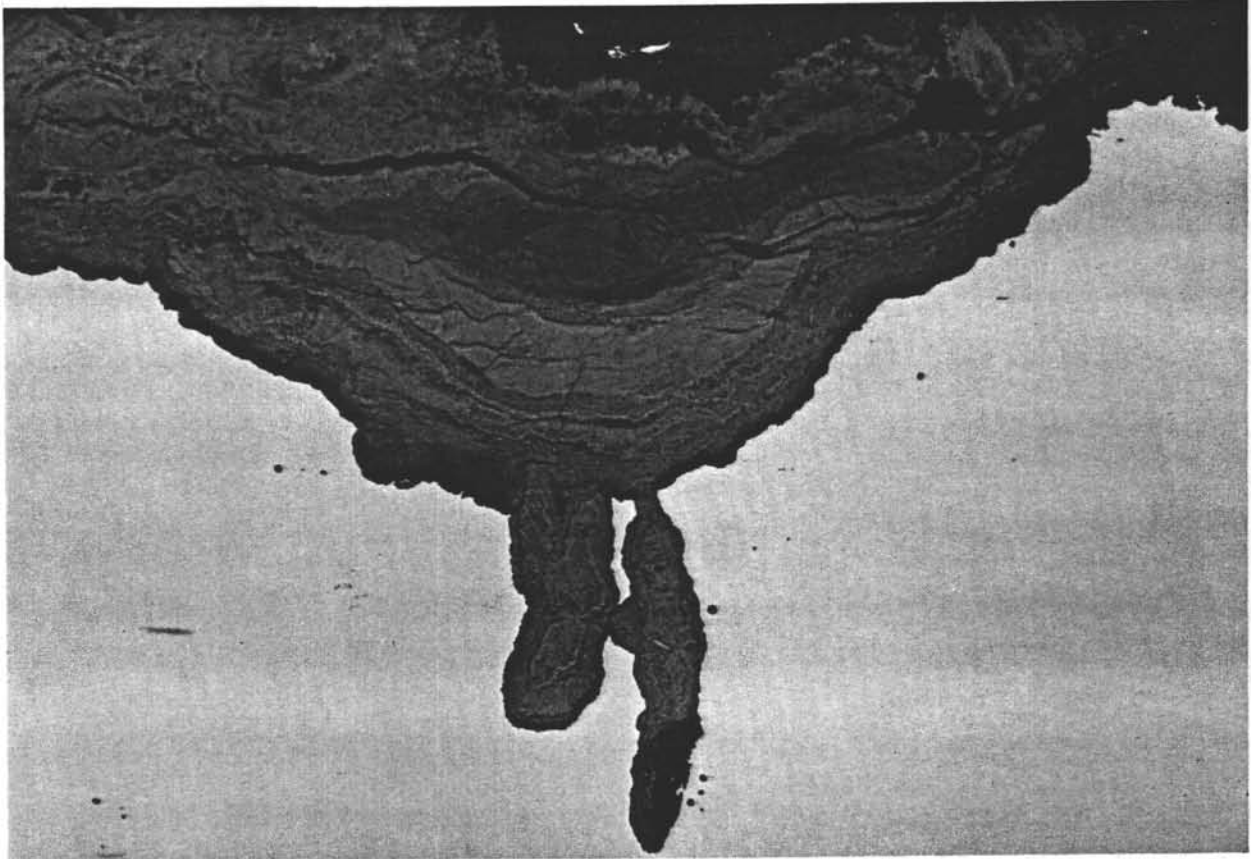
Irregularly-shaped corrosion pit on the inside surface of Sample A. Not etched. X300.

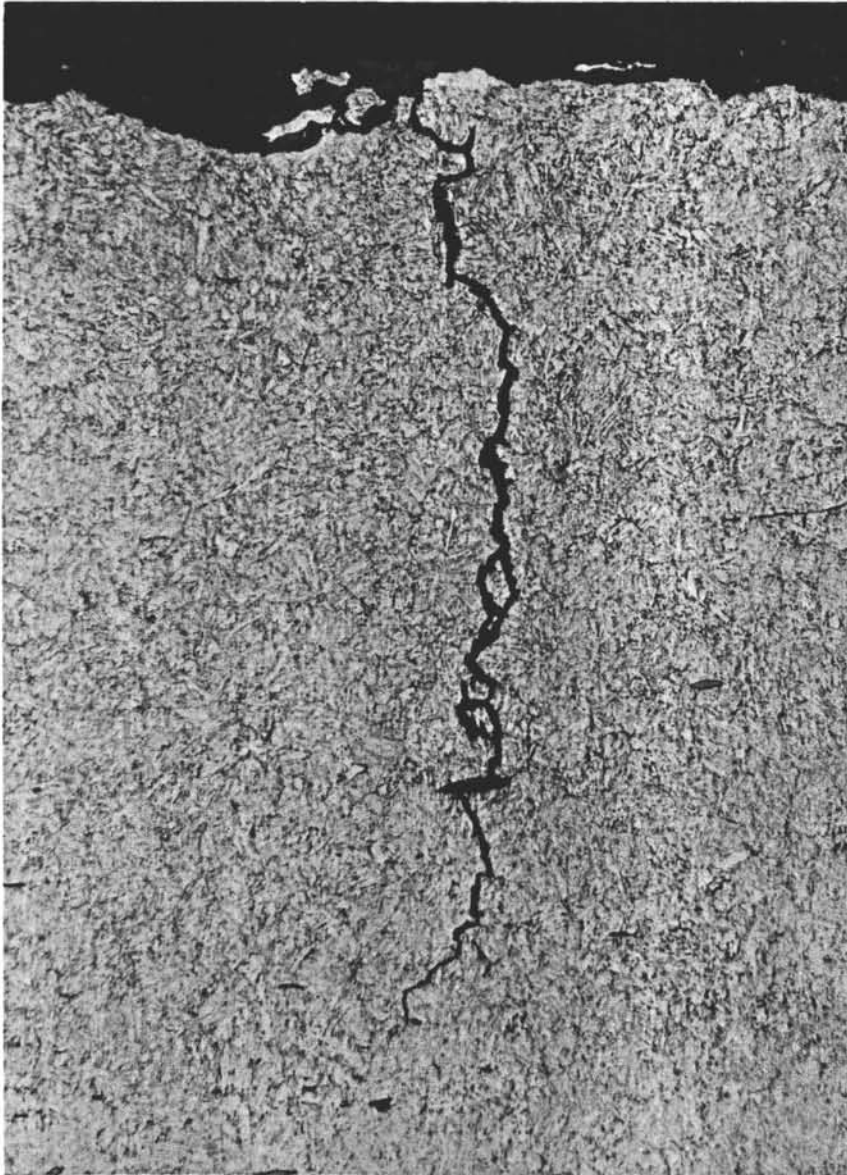
Etched in picral. X300.
