**INTERNATIONAL PHASE OF OCEAN DRILLING (IPOD)  
DEEP SEA DRILLING PROJECT  
DEVELOPMENT ENGINEERING  
TECHNICAL REPORT NO. 14**

## **DRILL STRING FAILURE ANALYSES**

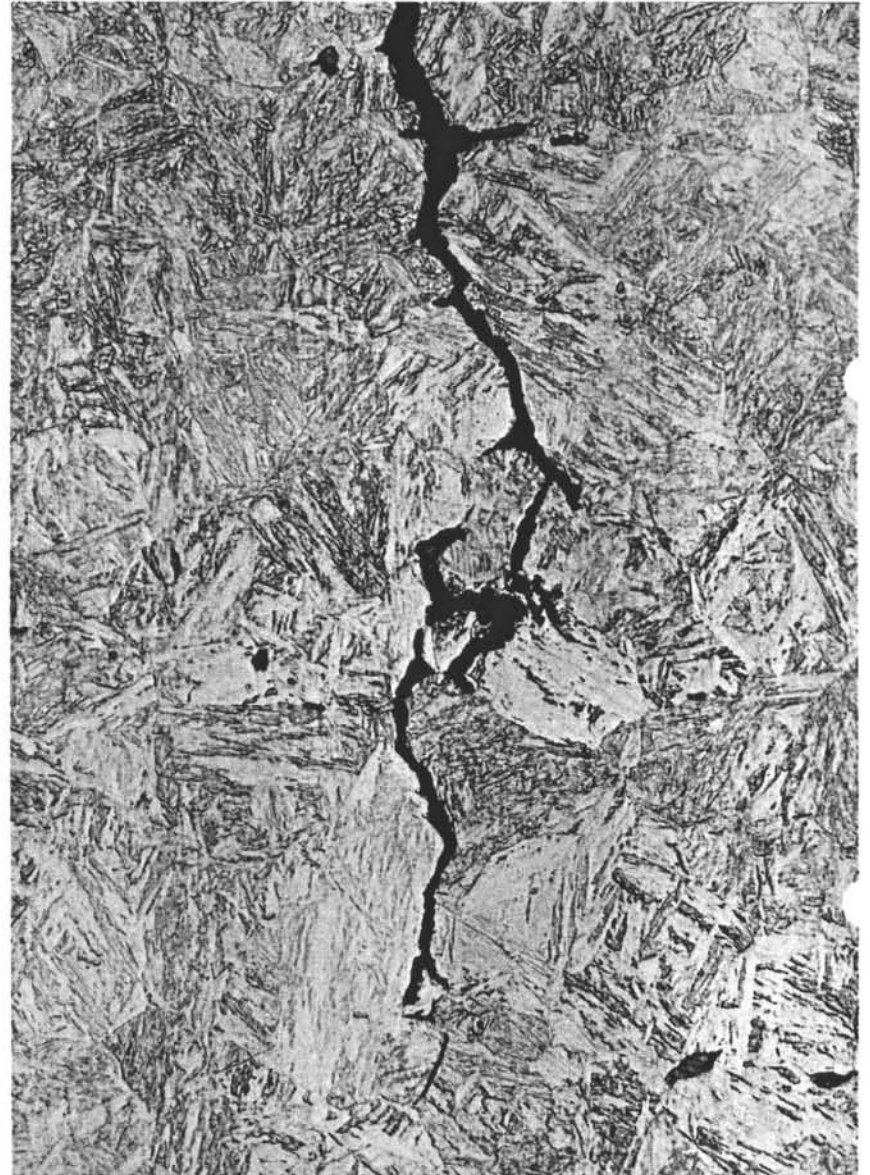
Etched in Vilella's Reagent. X750.

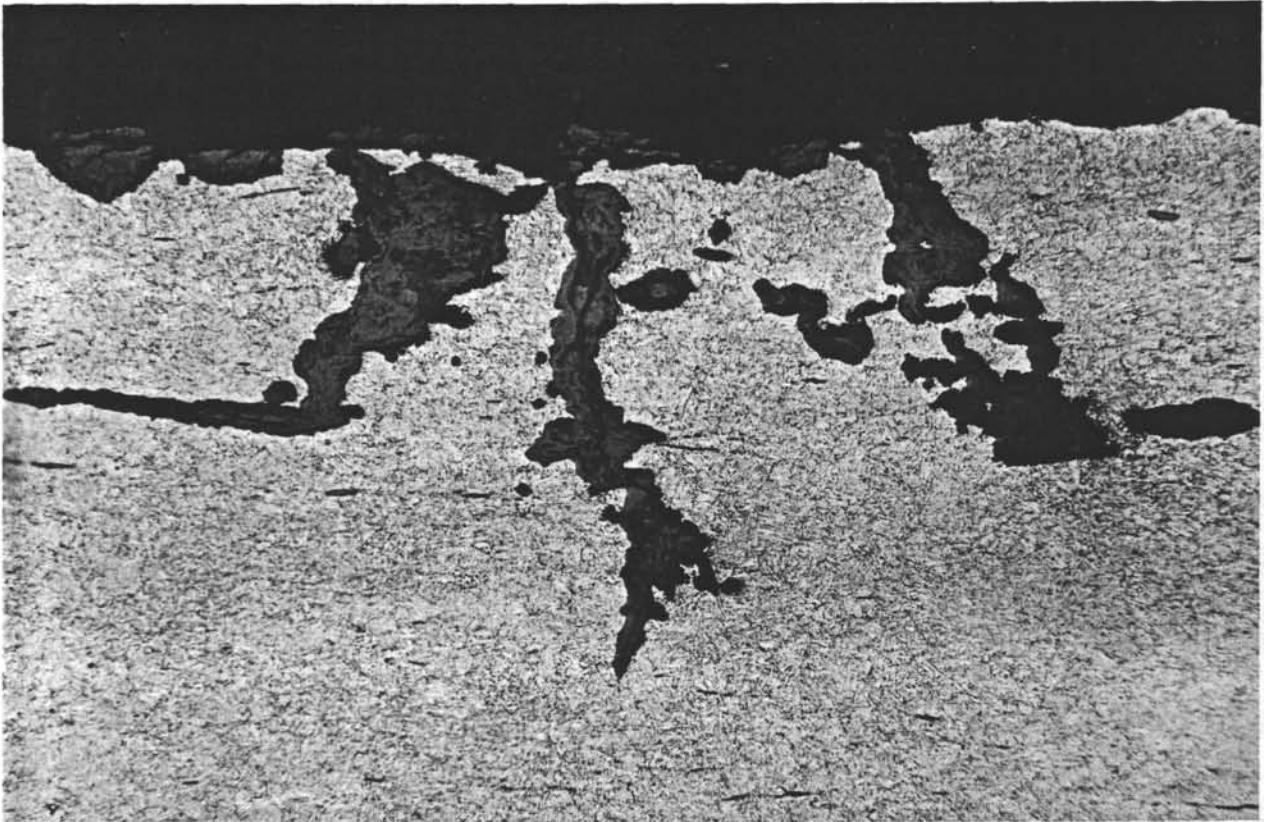
Irregular corrosion on the outside surface of  
Sample A. Etched in picral. X200.

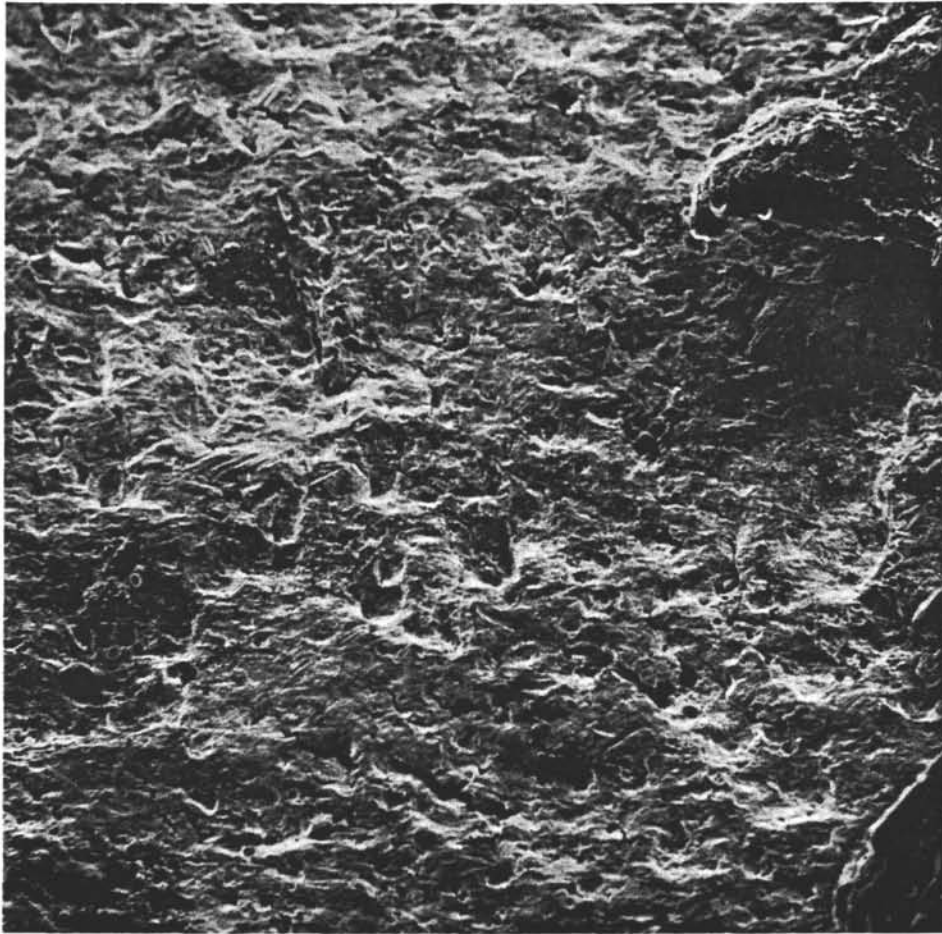
Flat fracture surface of Sample A after removal of corrosion product. Note corrosion pits and secondary cracks. X100.

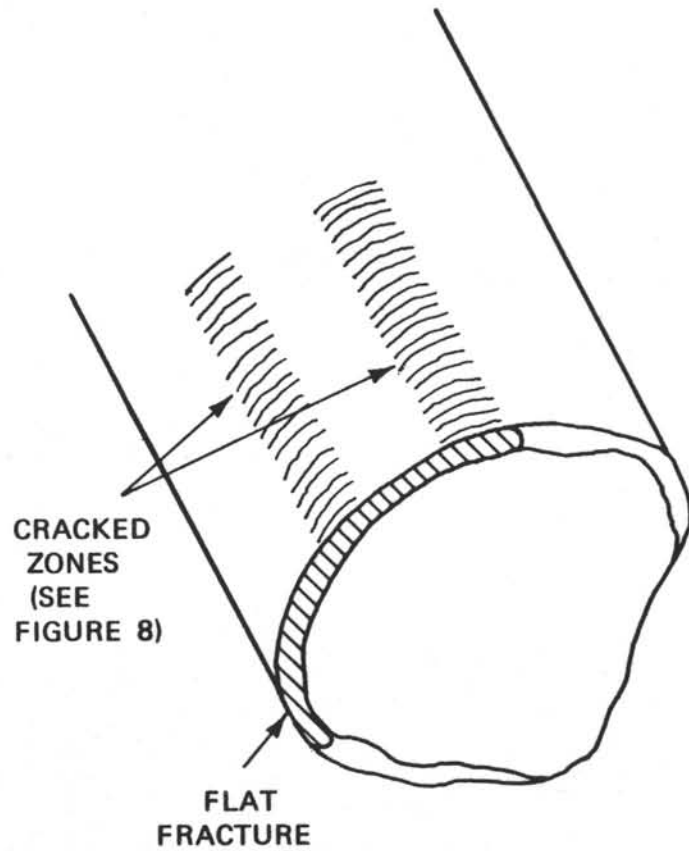
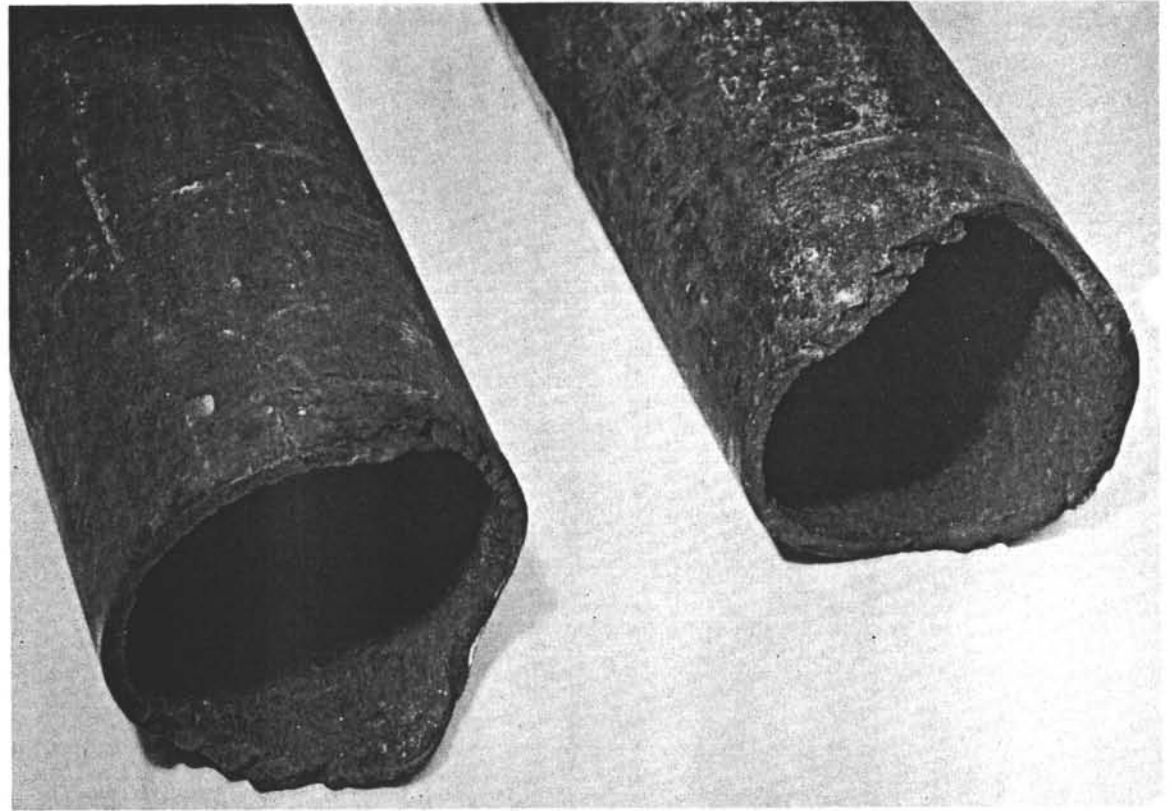
MATCHED FRACTURE FACES OF SAMPLE B.  
ABOUT 0.5 ACTUAL SIZE.

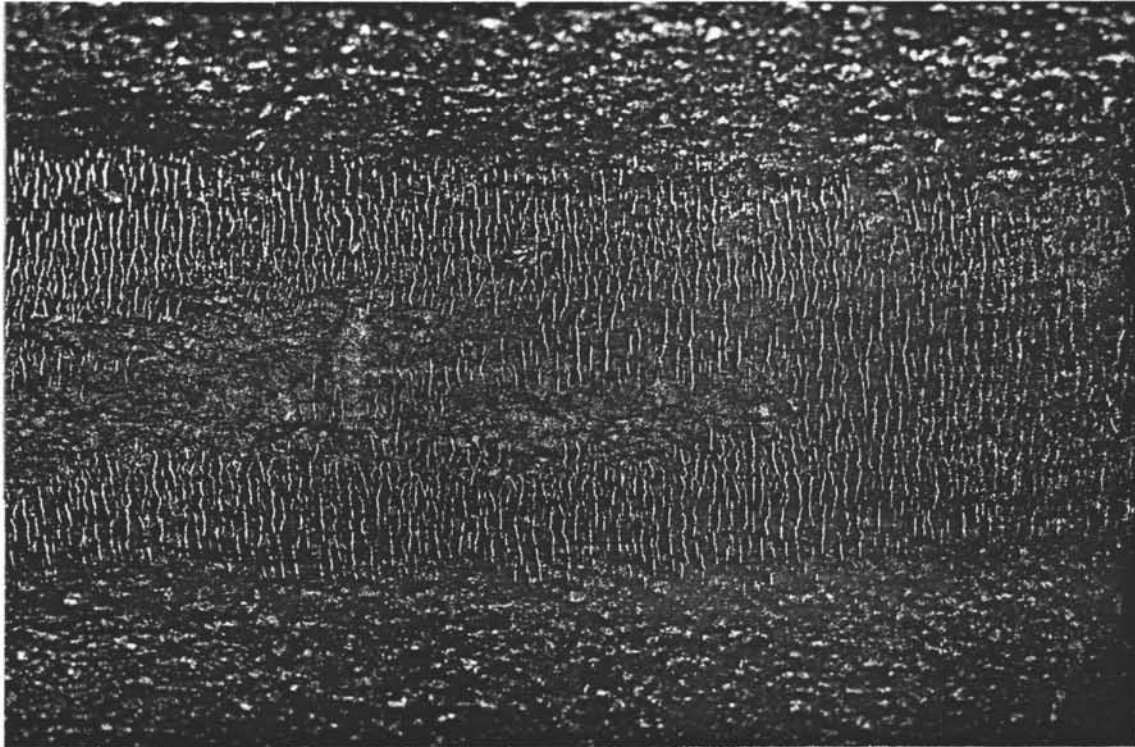
Cracked zone on the outside surface of Sample B. The cracks were revealed by fluorescent magnetic particle technique with ultraviolet illumination. X1.3.

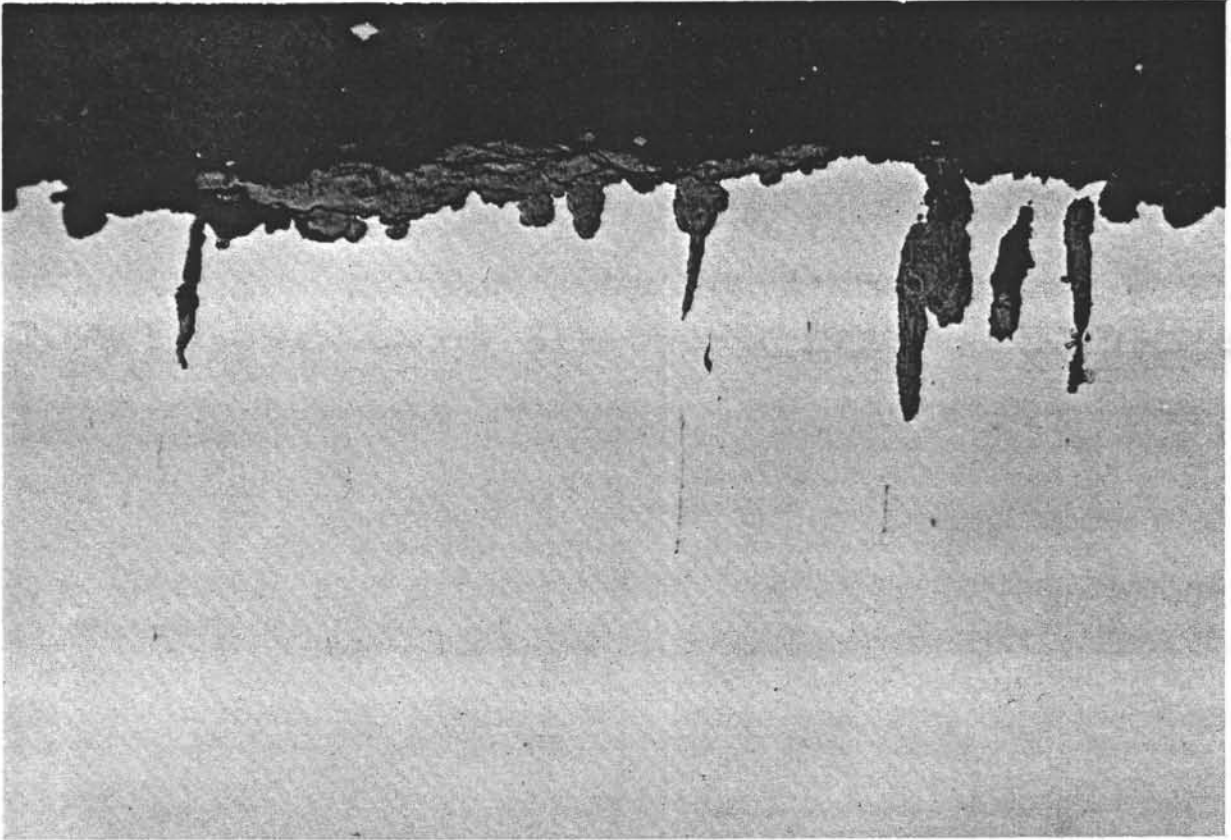
General corrosion and pitting on the flat fracture surface of Sample B. Not etched. X250.

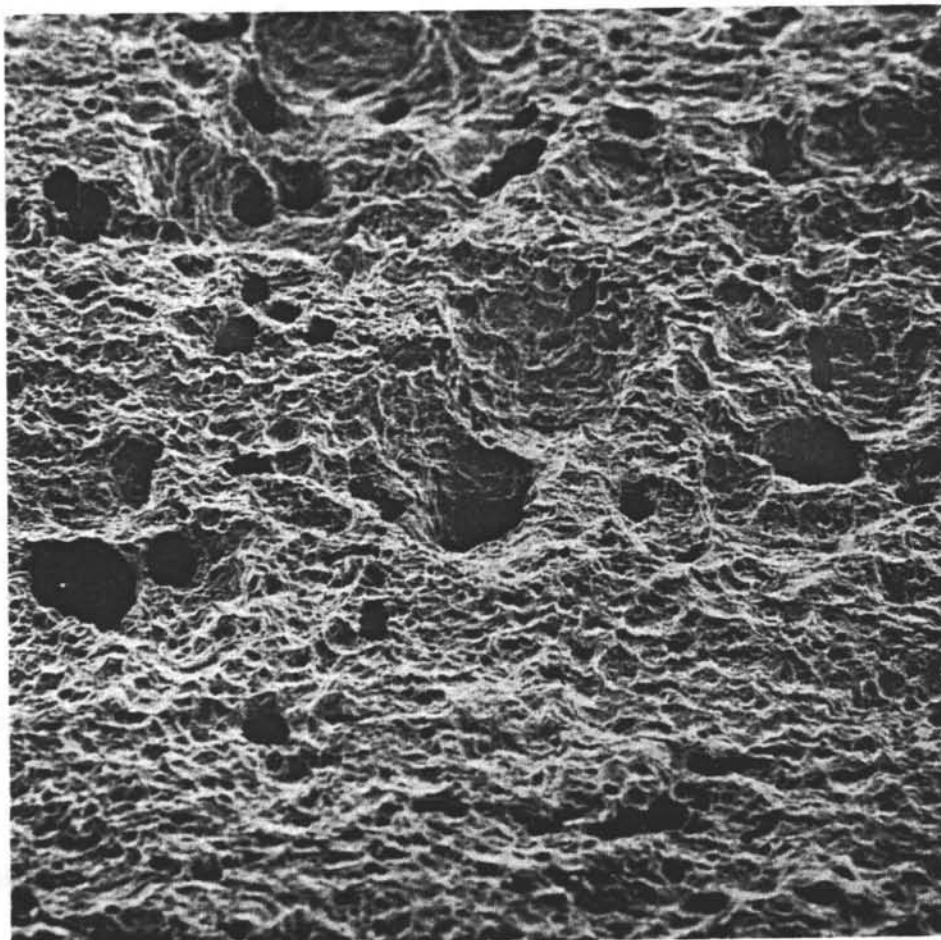
Flat fracture surface of Sample B after removal of corrosion product. X250.

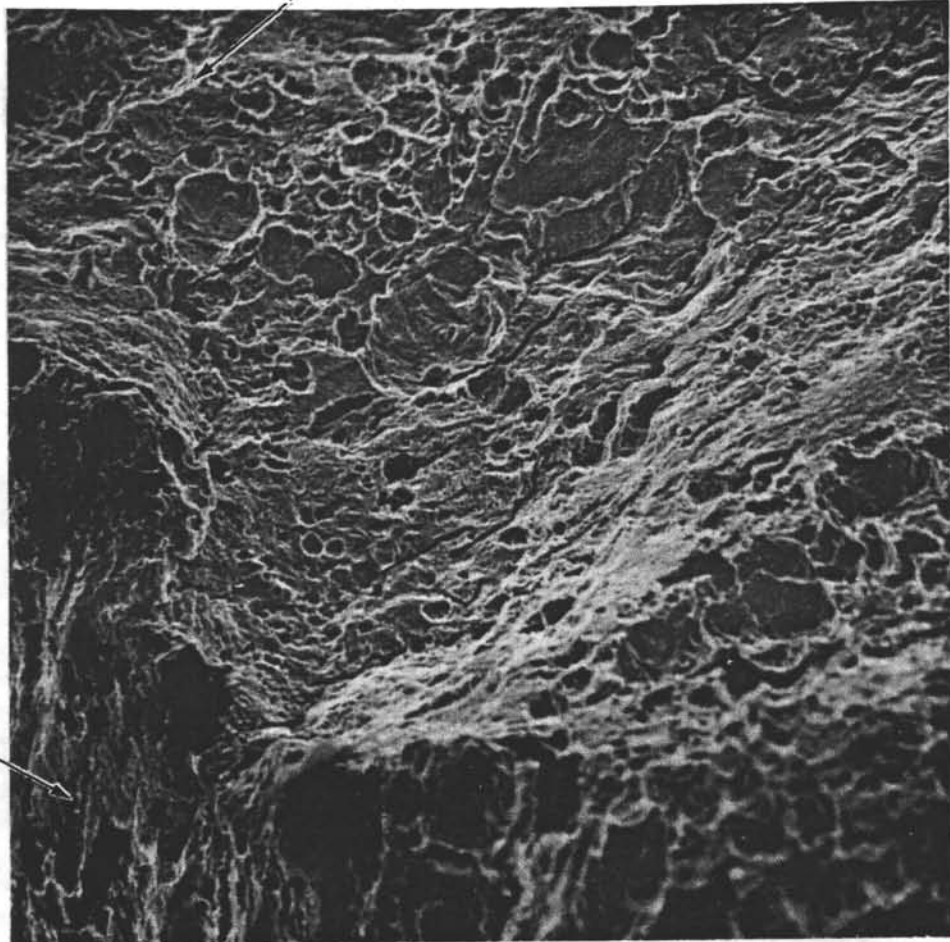
Branch cracks on flat fracture surface of Sample B.  
Area A in Figure 12. X500.

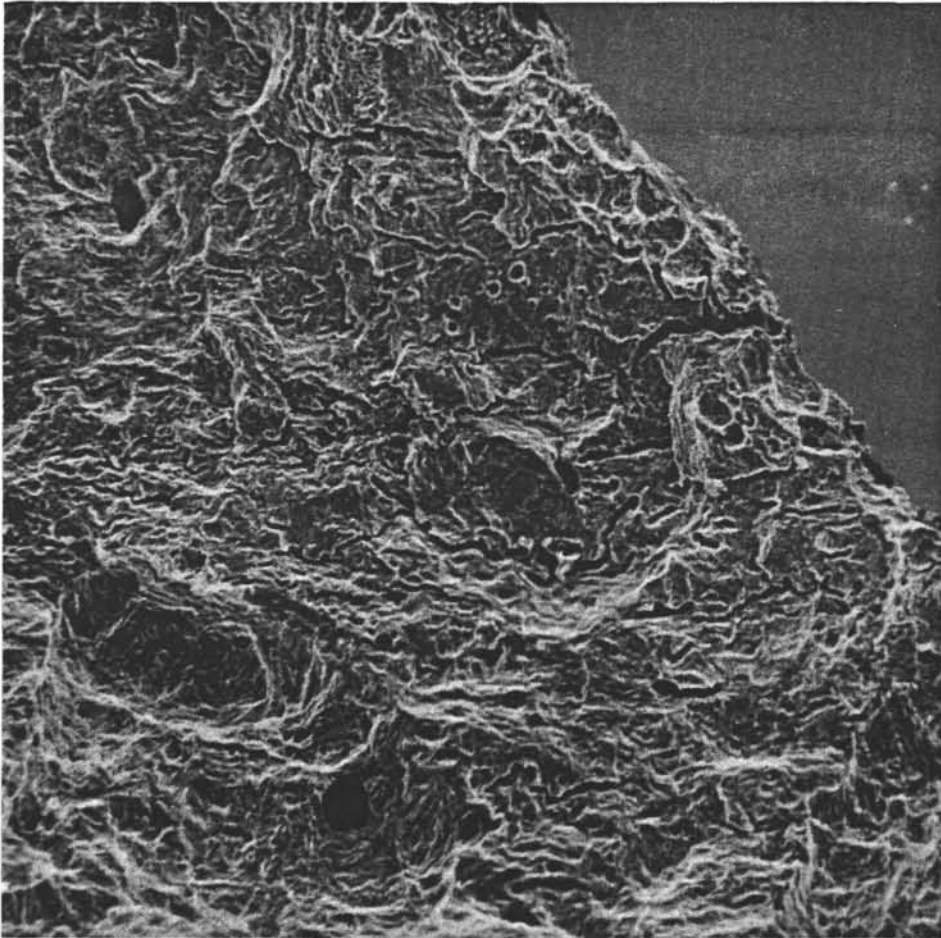
Branch cracks on flat fracture surface of Sample B.  
X500.

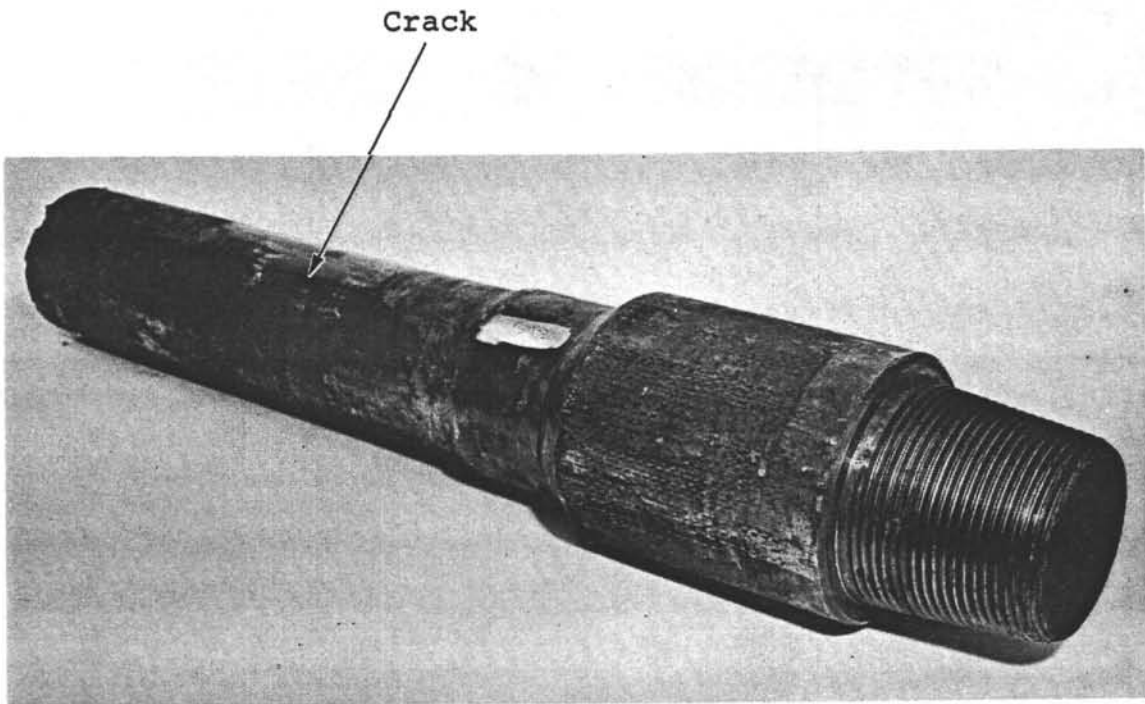
Sample C showing location of crack in relation to the pin end.

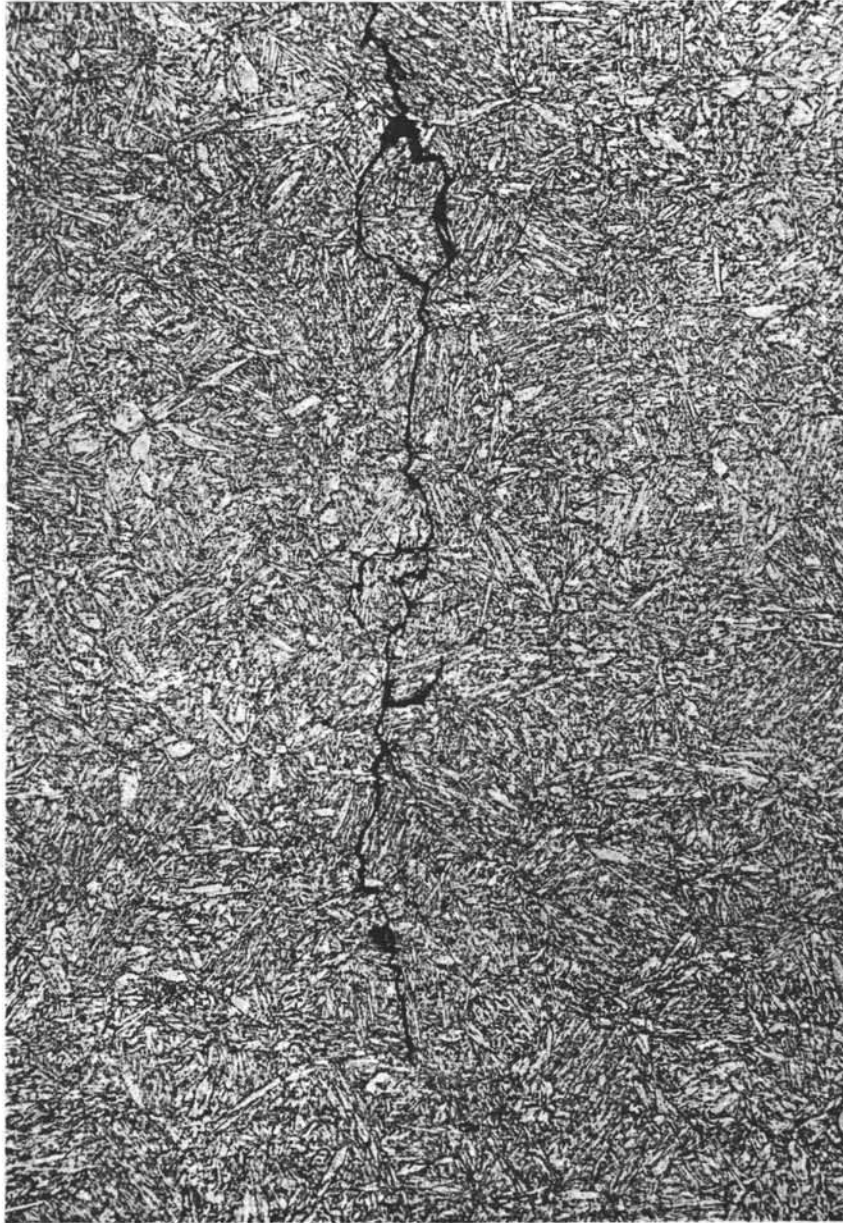
Tip of the crack shown in Figure 16. Etched in super picral. X500.

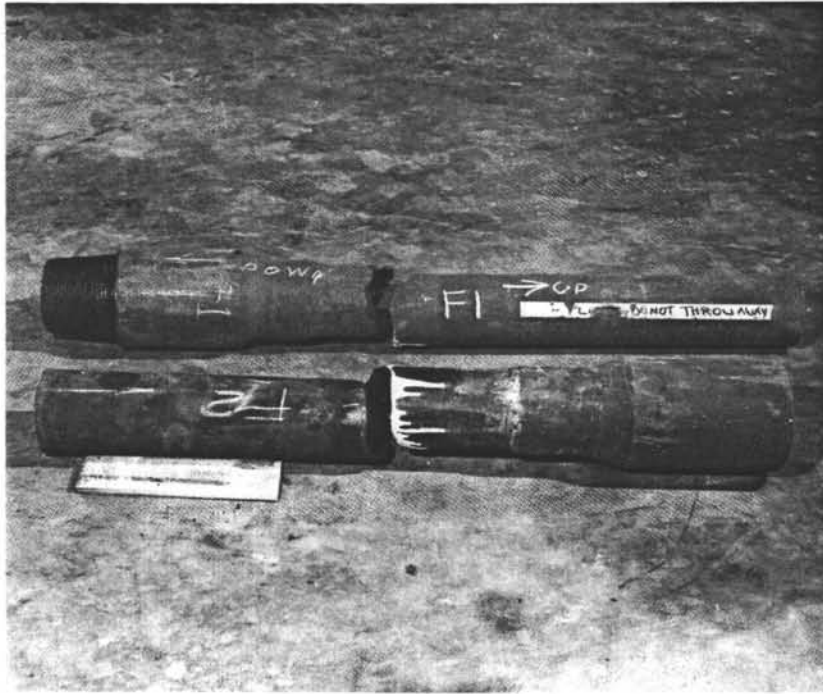
FIGURE 1. Schematic of DSDP Hole 504B.

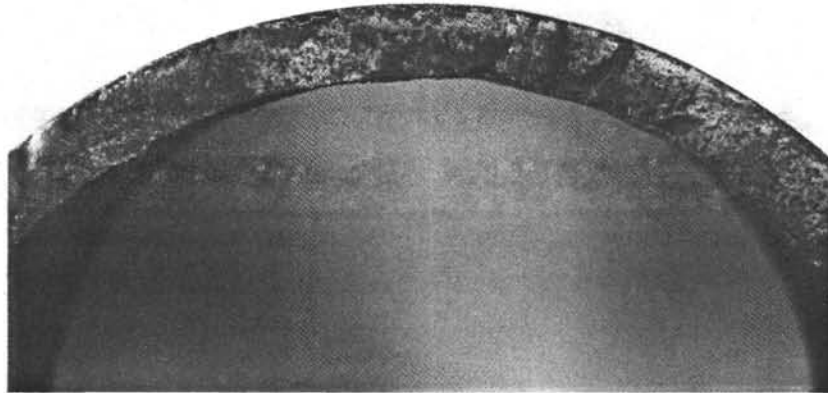
FIGURE 2. FRACTURED PIECES OF DRILL PIPE. (NOTE: WHITE SUBSTANCE ON F-2 BOX END FRACTURE IS SILICONE RUBBER FOR PROTECTING THE FRACTURE SURFACE)

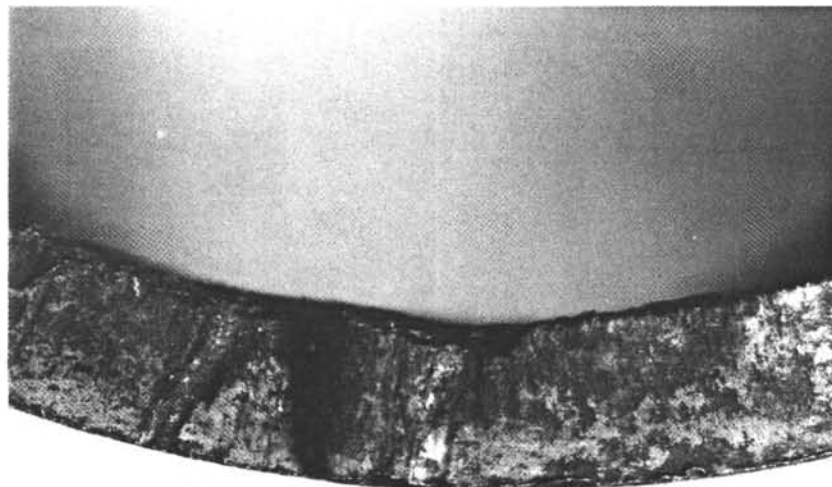
FIGURE 3. FRACTURE SURFACE OF F 1.  
 $\approx 1x$

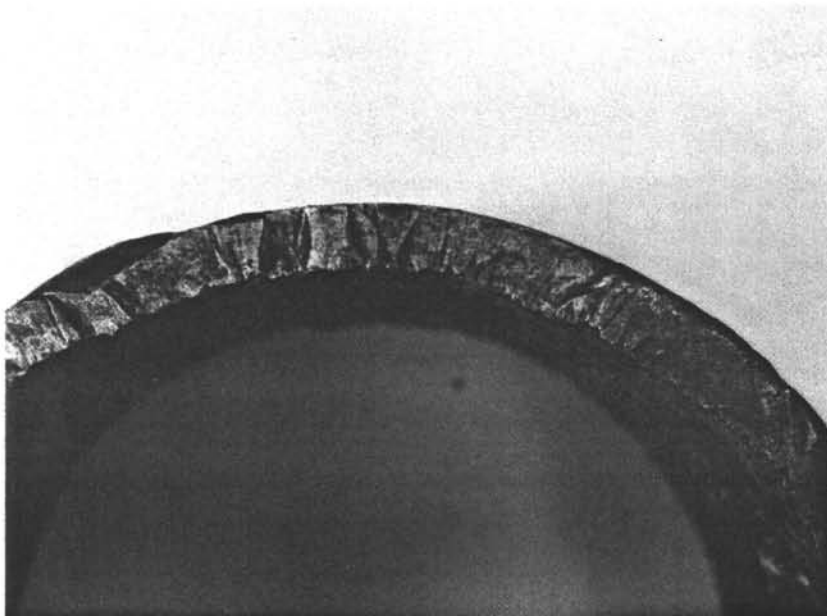
FIGURE 3A. CLOSE-UP OF FRACTURE FROM F 1. RATCHET  
MARKS INDICATE ORIGINS ON I.D. SURFACE.  
 $\approx 3x$

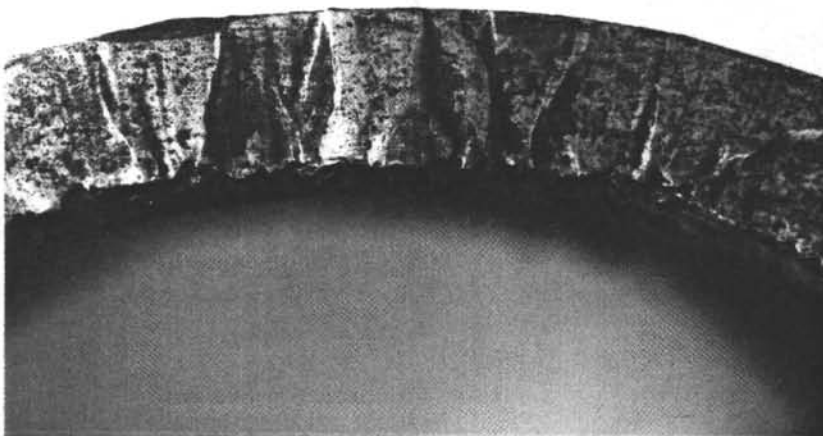
FIGURE 4. FRACTURE SURFACE OF F2.  
 $\approx 1x$

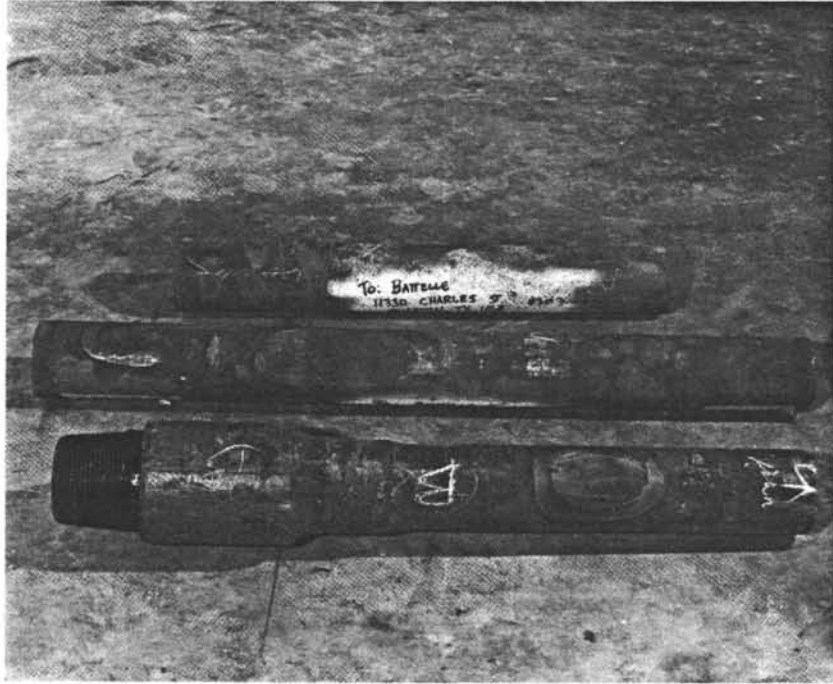
FIGURE 4A. CLOSE-UP OF FRACTURE FROM F2. RATCHET MARKS.  
INDICATE ORIGINS AT PITS ON I.D. SURFACE.  
 $\approx 3x$

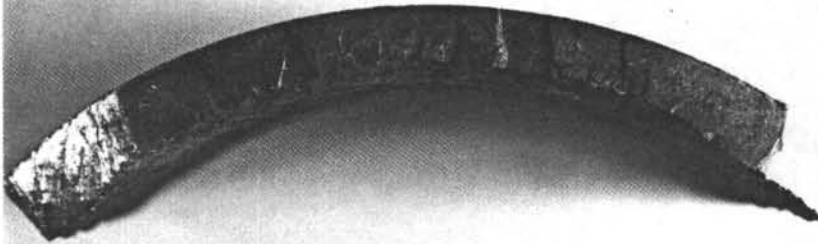
FIGURE 5. CRACKED PIPE JOINTS.

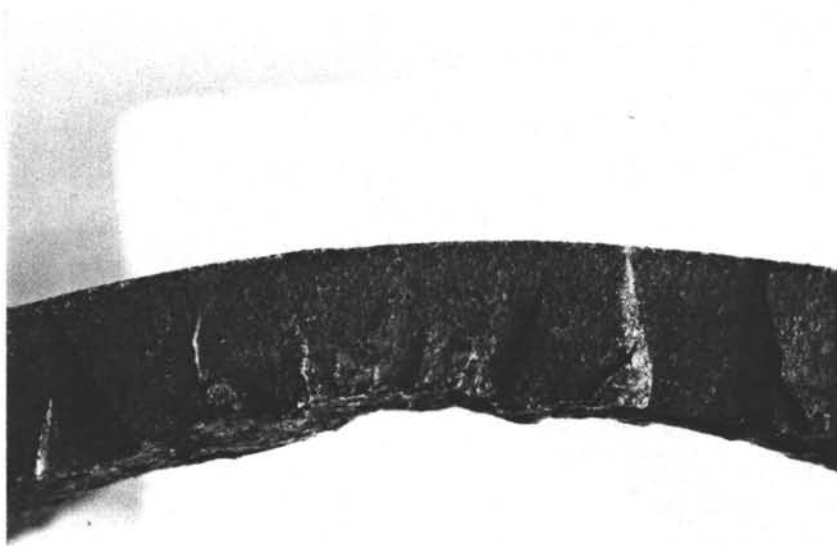
FIGURE 6. FRACTURE SURFACE OF CRACK EXPOSED IN SAMPLE A.  
1x

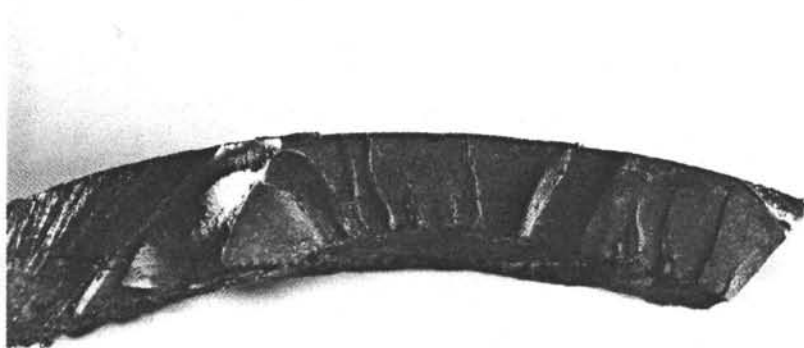
FIGURE 7. CLOSE-UP OF FRACTURE SURFACE FROM SAMPLE A.  
3.8x

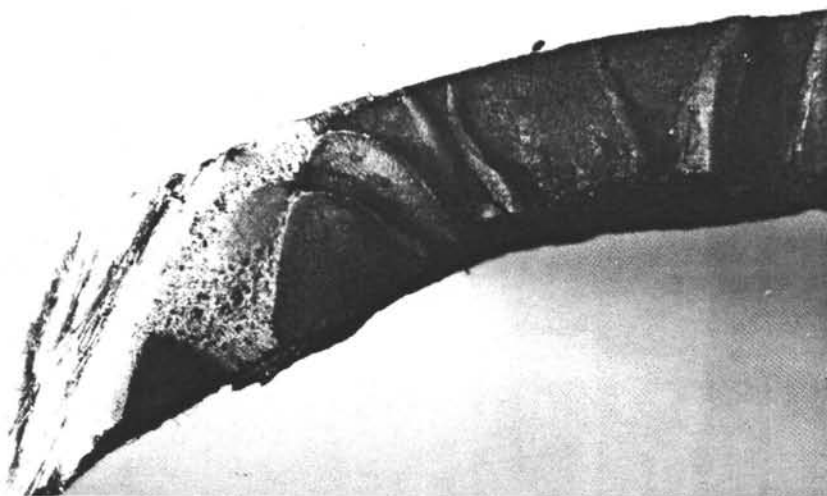
FIGURE 8. FRACTURE SURFACE EXPOSED IN SAMPLE B.  
2.2x

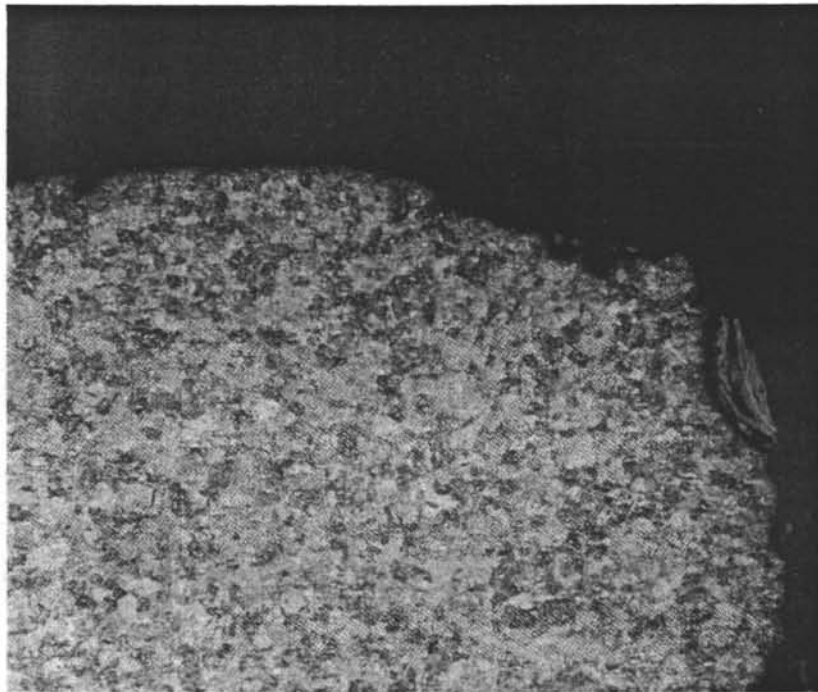
FIGURE 9. CLOSE-UP OF FRACTURE SURFACE FROM SAMPLE B.  
3.3x

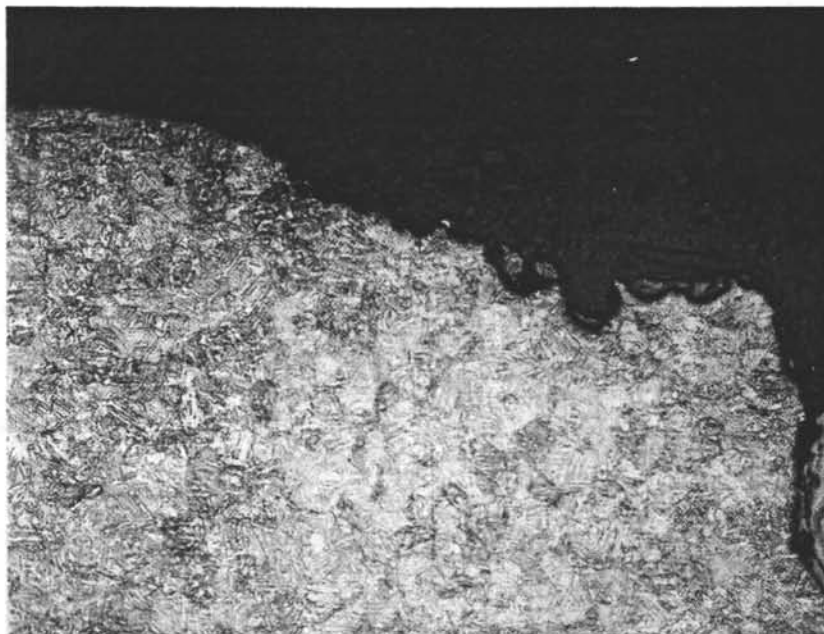
FIGURE 10. PHOTOMICROGRAPH FROM A SECTION THROUGH A FRACTURE ORIGIN ON SAMPLE F 1. 62.5x, NITAL ETCH

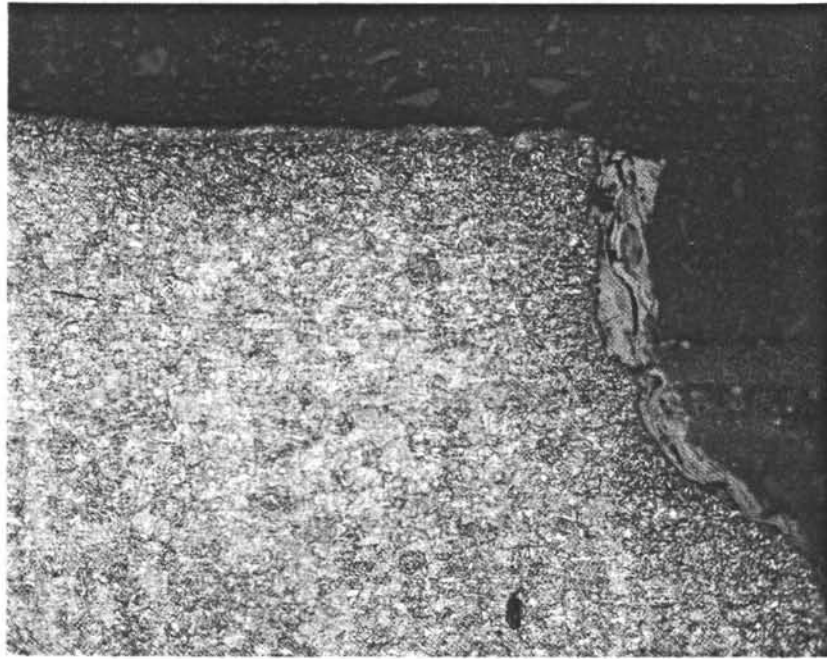
FIGURE 11. HIGHER-MAGNIFICATION PHOTOMICROGRAPH OF ORIGIN IN FIGURE 10. 125x

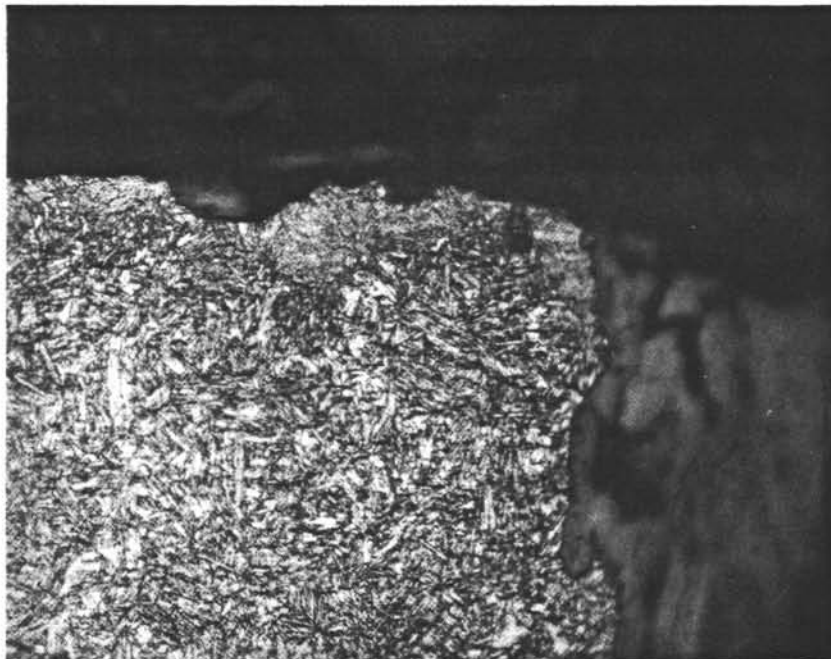
FIGURE 12. PHOTOMICROGRAPH FROM A SECTION THROUGH A FRACTURE ORIGIN ON SAMPLE A. FRACTURE PROFILE IS AT TOP.—  
125x, NITAL ETCH

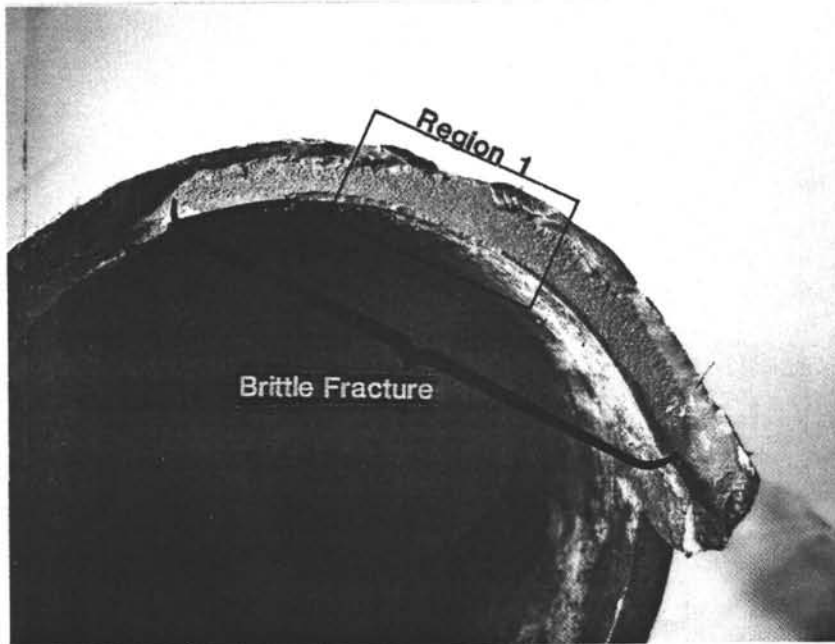
FIGURE 1. AS RECEIVED PHOTOGRAPH OF FAILED JOINT. THE ARROW POINTS TO THE FRACTURE ORIGIN AND THE ROLLED IN LAP.

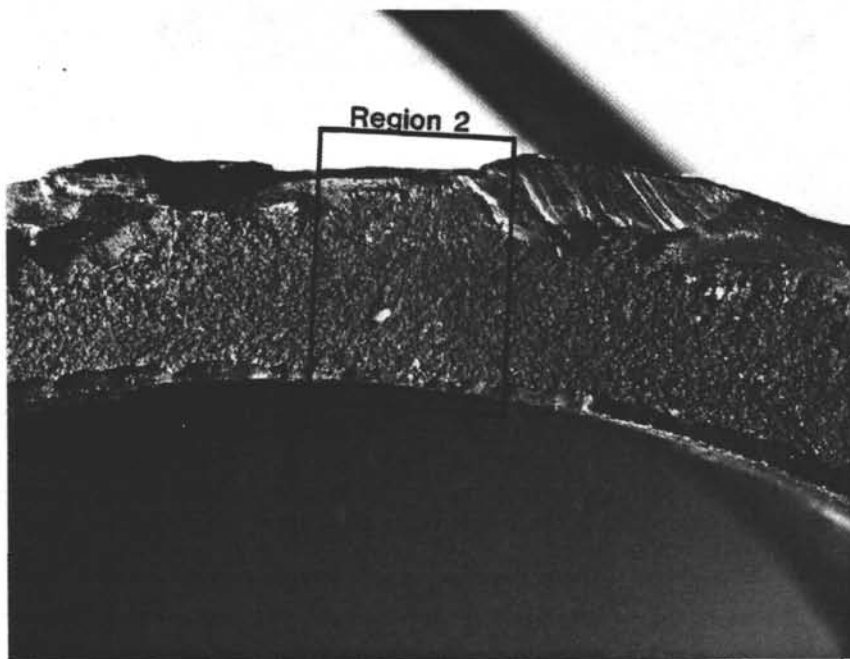
FIGURE 2. THE BRITTLE FRACTURE EXTENDED APPROXIMATELY 90 DEGREES AROUND THE CIRCUMFERENCE OF THE PIPE. THE BOXED IN AREA, REGION 1, IS SHOWN MAGNIFIED IN FIGURE 3.

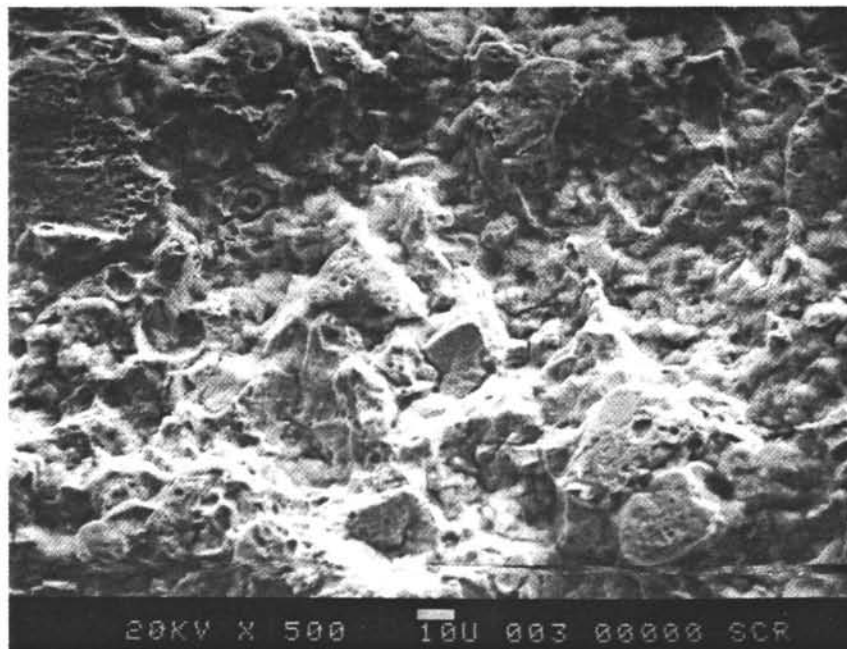
FIGURE 6. SEM MICROGRAPH OF REGION 2 CLEARLY SHOWS CHEVRON MARKS POINTING TO ORIGIN (BRACKETED REGION), 11X.

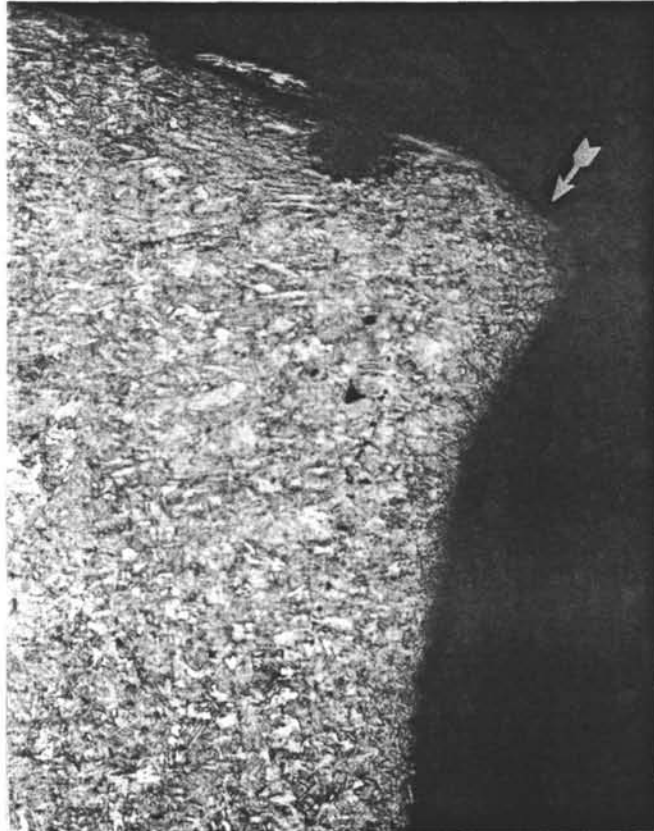
FIGURE 7. A HIGH MAGNIFICATION (500X) VIEW NEAR THE ORIGIN REVEALS AN INTERGRANULAR MODE OF FRACTURE. THIS FRACTURE MODE IS TYPICAL OF HYDROGEN EMBRITTLEMENT.

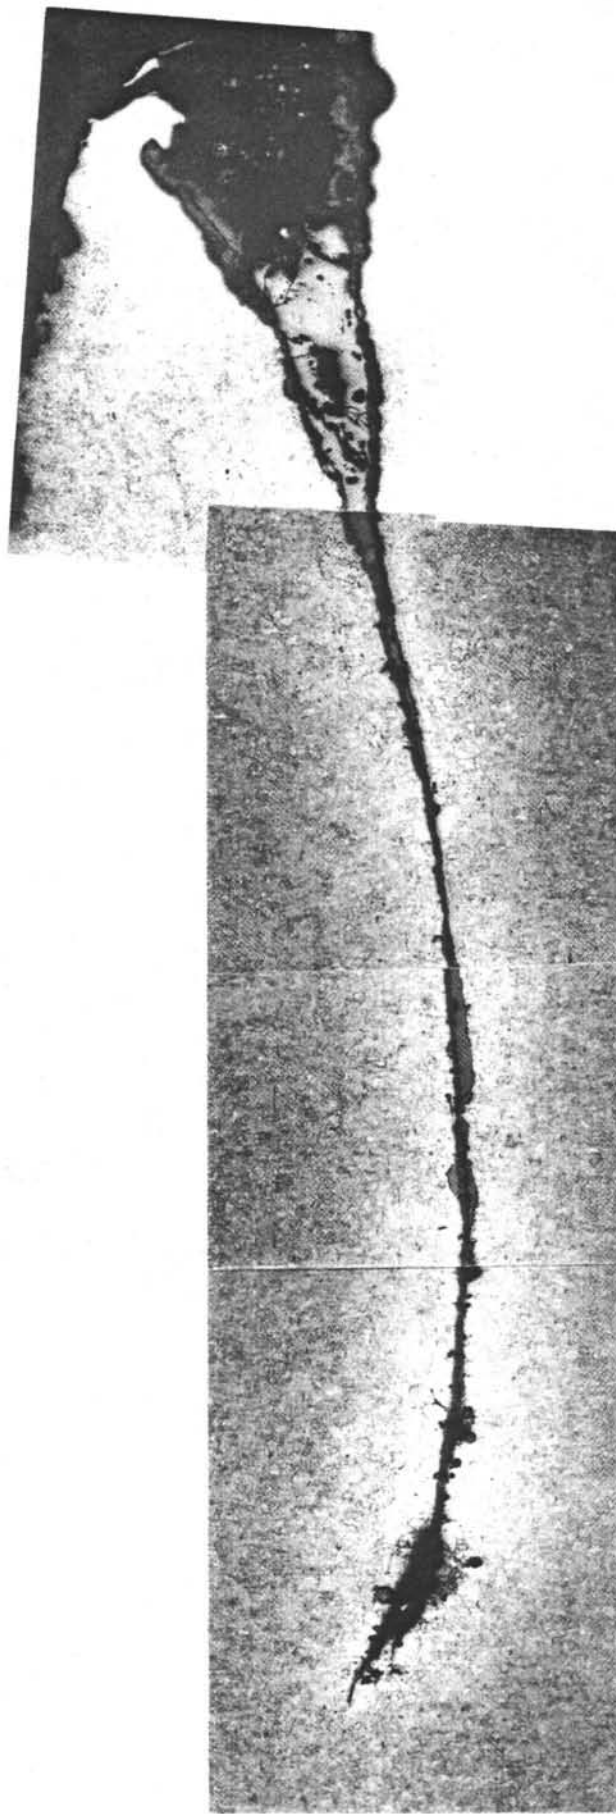
BHO 1484, 1485, 1486, 1487

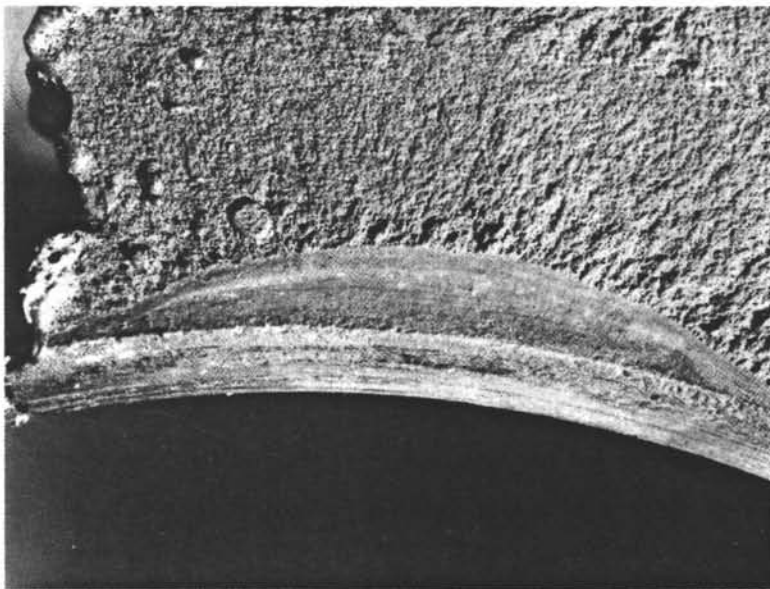
FIGURE 2. Largest fatigue  
zone on the  
fracture surface.  
 $\approx 1.5X$

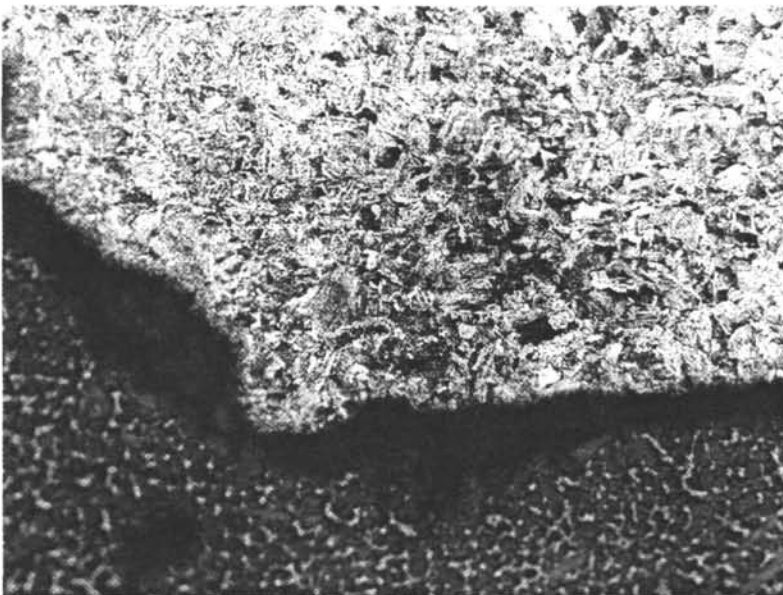
FIGURE 3. Photomicrograph of section taken through the largest fatigue origin. Note mixed micro-structure. 200X Nital etchant

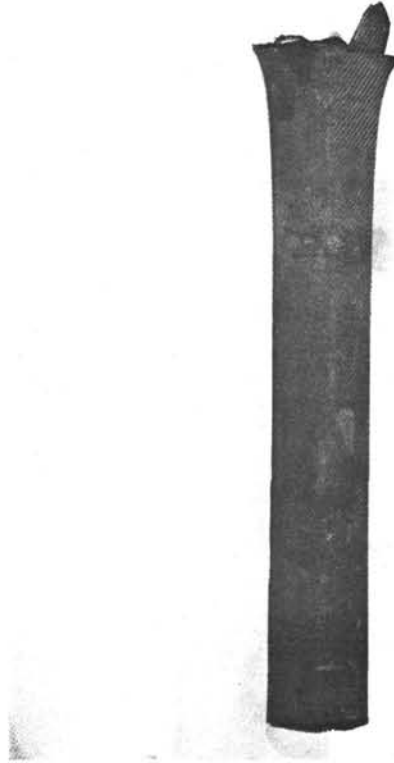
Numerous secondary cracks were observed on both the inside and outside surface of the drill pipe section. Most of these cracks were relatively blunt, transgranular and filled with corrosion products.

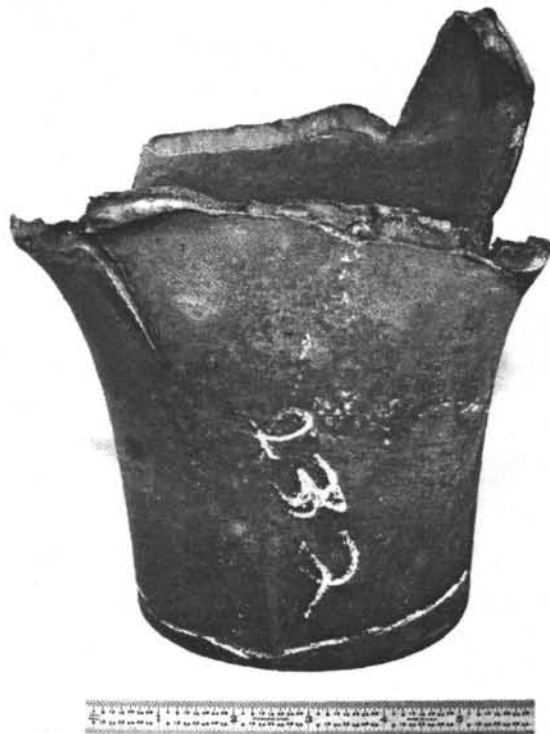
FIGURE 1. FAILED DRILL PIPE SECTION AS RECEIVED

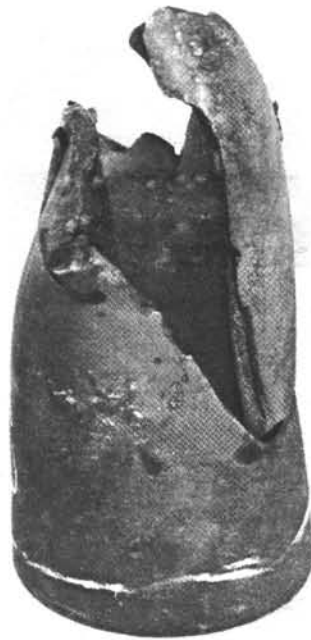
FIGURE 2. FRACTURED DRILL PIPE END, LOOKING AT THE CENTER OF THE BUCKLED ZONE.
