**INTERNATIONAL PHASE OF OCEAN DRILLING (IPOD)  
DEEP SEA DRILLING PROJECT  
DEVELOPMENT ENGINEERING  
TECHNICAL REPORT NO. 14**

## **DRILL STRING FAILURE ANALYSES**

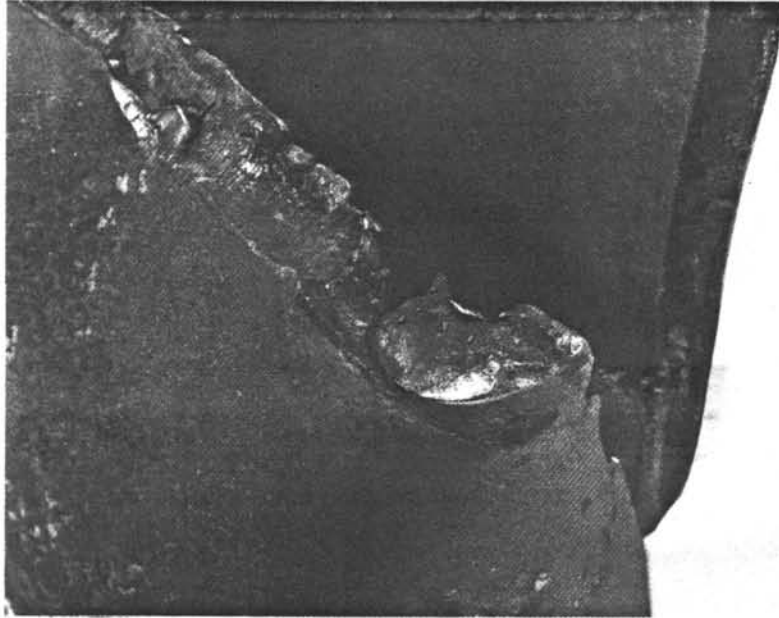
FIGURE 4. BACK VIEW OF THE BUCKLE. THE LONGI-  
TUDINAL SPLIT IN FIGURE 3 TURNS 90°  
AND RUNS PERPENDICULAR TO THE LENGTH  
OF THE DRILL PIPE.

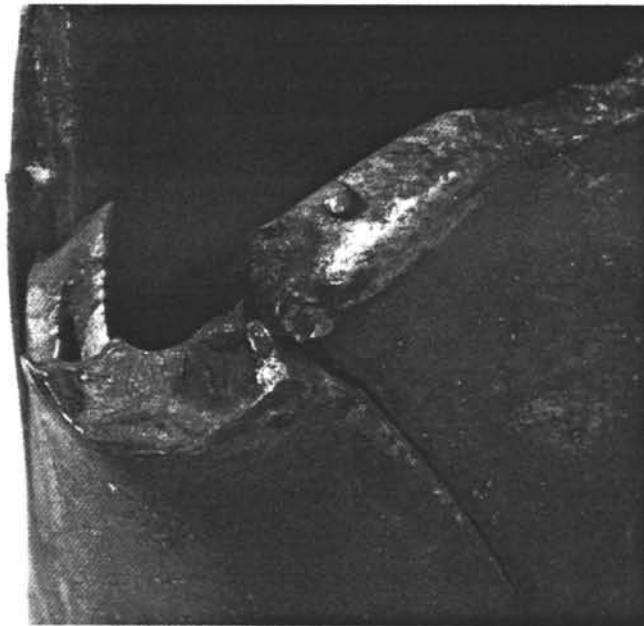
FIGURE 5. FATIGUE ZONE AT THE OUTER EDGE OF THE BUCKLE. NOTE THE SECONDARY CRACK BELOW THE FATIGUE ZONE.

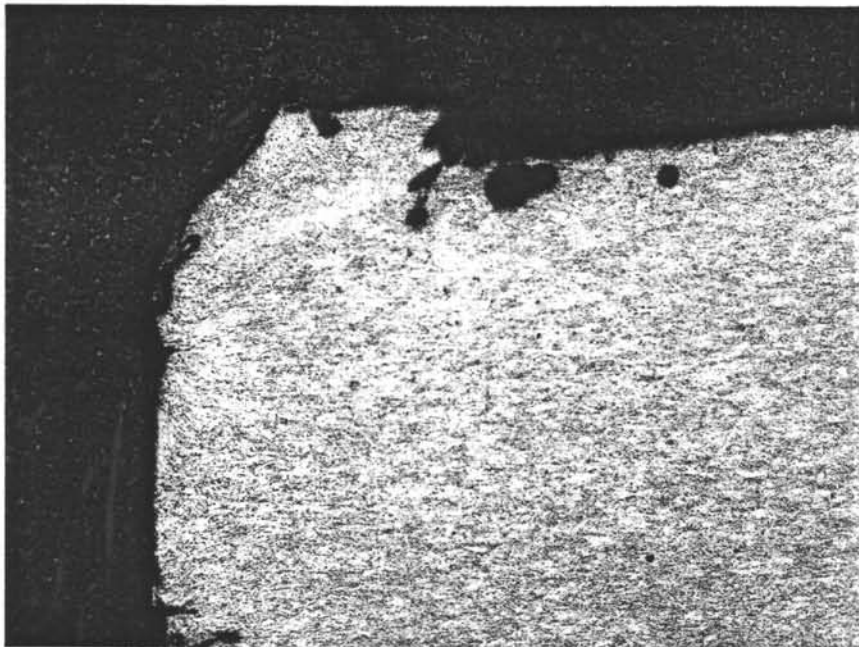
FIGURE 7. CLOSE-UP OF FATIGUE ZONE IN FIGURE 5. NOTE THE RADICAL MARKS INDICATING INITIATION AT THE OUTER EDGE.

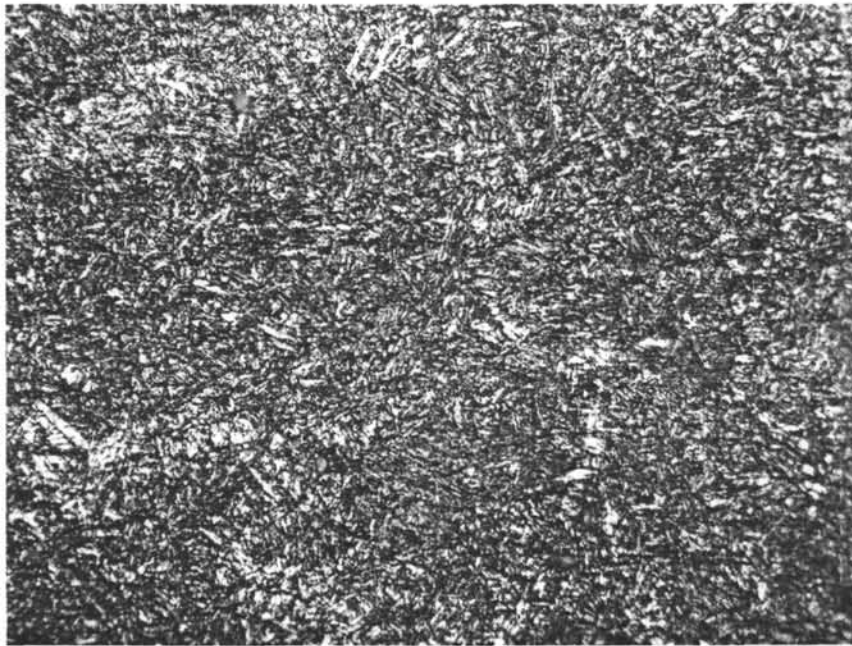
Although the yield strength of the failed drill pipe is near the high end of the allowable range, the mechanical properties meet the API 5AX specification in all respects.

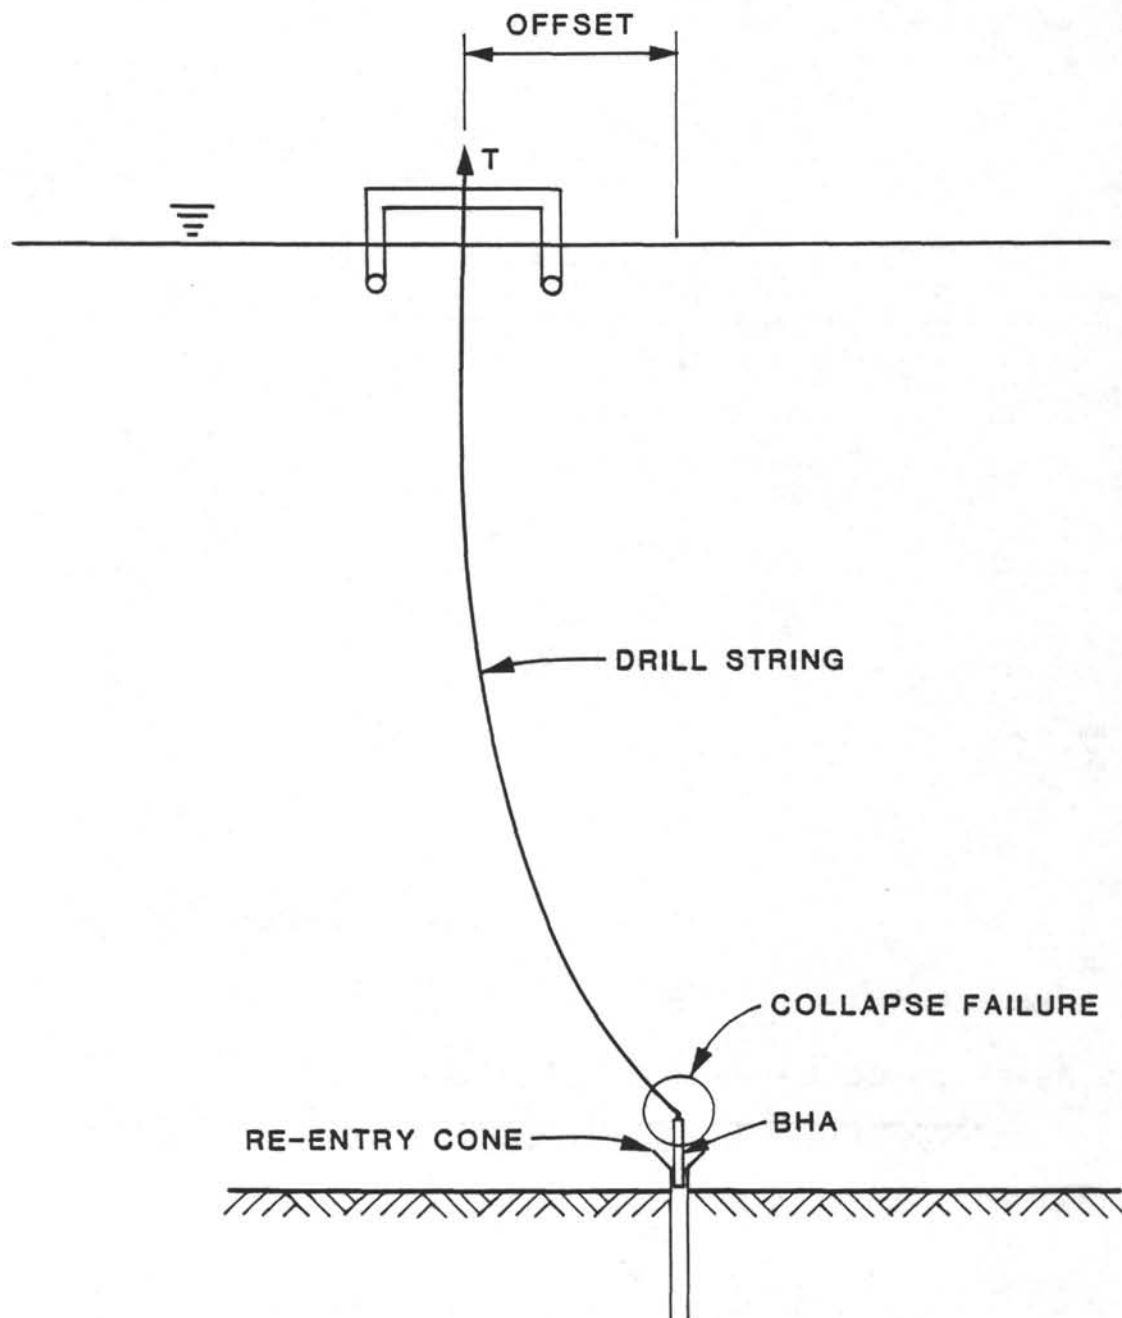
Figure 11- SCHEMATIC FOR COLLAPSE FAILURE SCENARIO

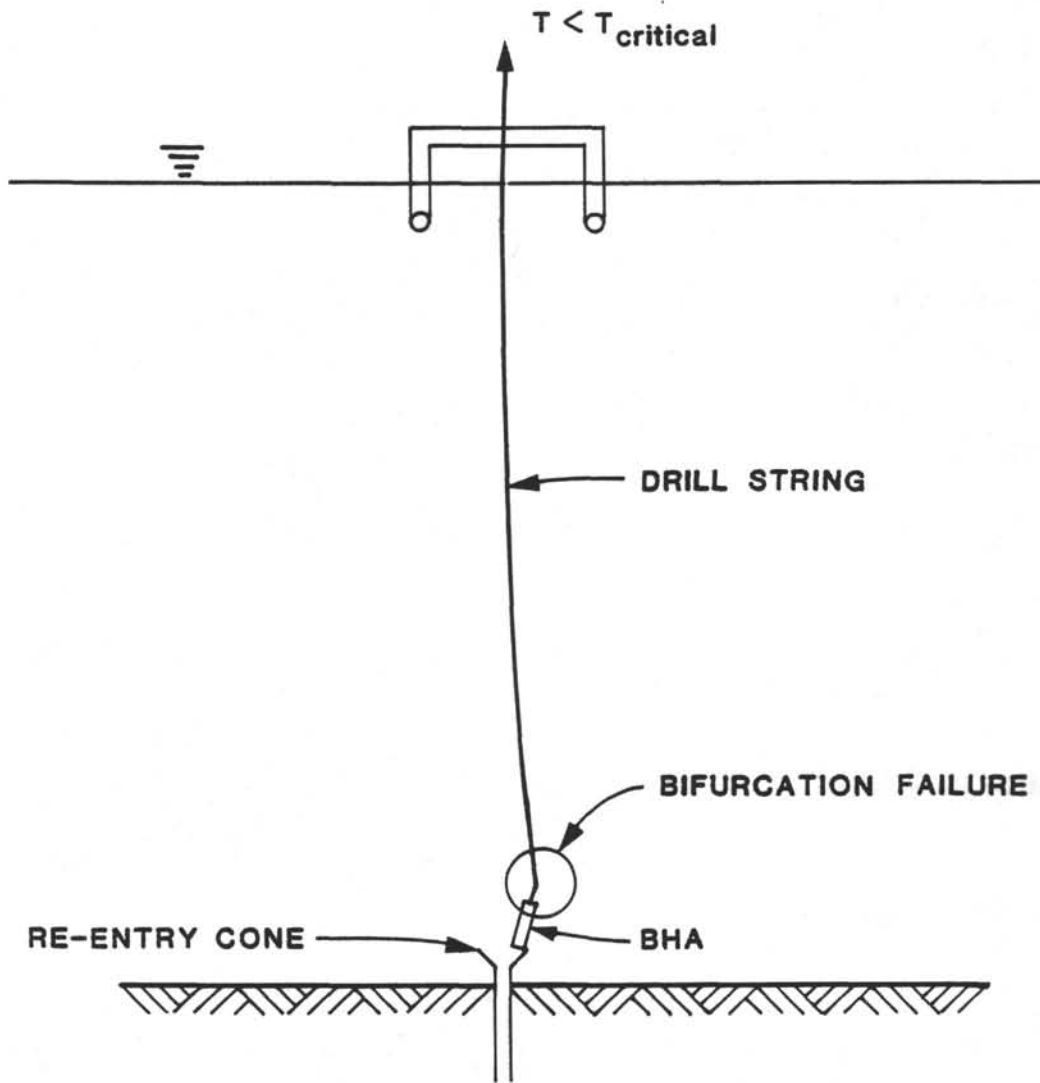
Figure 12- SCHEMATIC FOR BIFURCATION (COLUMN INSTABILITY) FAILURE SCENARIO

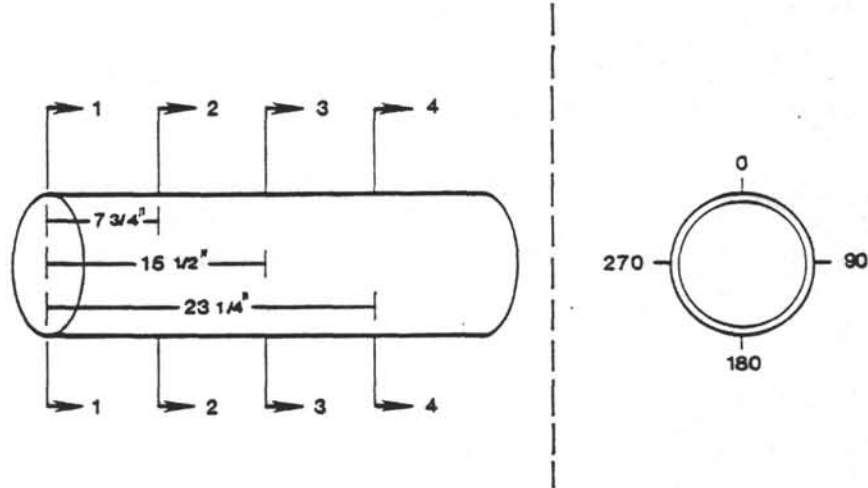
Section	Orientation	Outer Diameter in.	Inner Diameter in.	Wall Thickness in.	O.D. - Nominal, in.	Wall Thickness - Nominal, in.	Ovality (O.D. 0 - O.D. 90) in.
1	0	5.010	4.281	0.359	+0.010	-.003	0.002
	90	5.008	4.278	0.356	+0.008	-.006	
	180	*	*	0.370		+0.008	
	270	*	*	0.374		+0.012	
2	0	5.010	4.275	0.361	<del>+0.010</del> +0.010	-.001	0.015
	90	5.025	4.291	0.358	+0.025	-.004	
	180	*	*	0.371		+0.009	
	270	*	*	0.376		+0.014	
3	0	5.015	4.277	0.362	<del>+0.015</del> +0.015	0.0	0.002
	90	5.017	4.285	0.353	+0.017	-.009	
	180	*	*	0.376		+0.014	
	270	*	*	0.379		+0.017	
4	0	5.012	4.271	0.357	+0.012	-.005	0.012
	90	5.024	4.296	0.352	<del>+0.024</del> +0.024	-.010	
	180	*	*	0.384		+0.022	
	270	*	*	0.384		+0.014	
API 5AX Spec.		5.0 nom.		0.362 nom.	±.0375 <sup>1</sup> max.	-.045 <sup>2</sup> max	0.093 max
