**DEEP SEA DRILLING PROJECT
TECHNICAL REPORT NO. 7
OPERATIONS RESUMES – PART III
CONTRACT NSF C-482**

OPERATIONS RESUMES

LEG 26 through LEG 33

DEEP SEA DRILLING PROJECT
Scripps Institution of Oceanography
University of California at San Diego

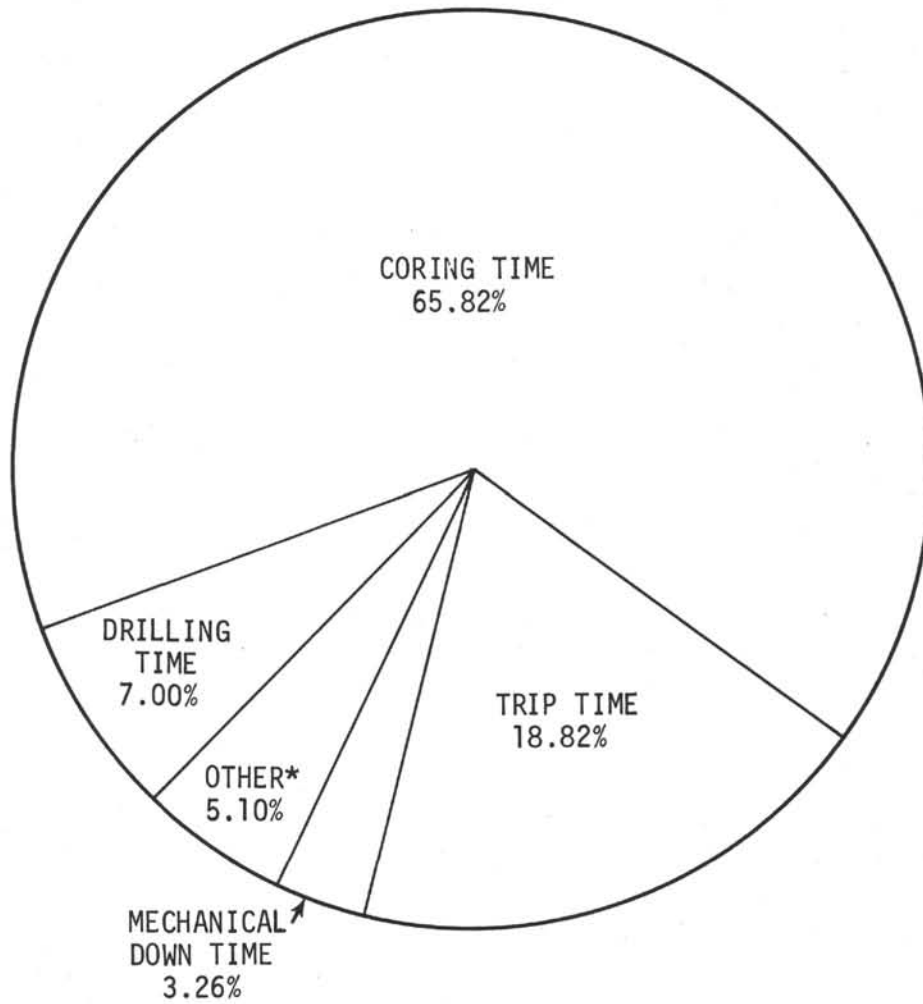
FIGURE 2
DEEP SEA DRILLING PROJECT
LEG XXVII
SITE TIME DISTRIBUTION

*Includes: Segregating pipe, Inspecting D.C. Heat Flow, profiling, time lost positioning and other miscellaneous lost time.

Major time distribution for the 51.01 day leg consisted of 13.55 days in port, 16.31 days cruising and 21.15 days on site. Of the 21.15 days on site, 13.92 days were spent coring, 1.48 days drilling, 3.98 days on trips and 1.77 days on mechanical down time and other miscellaneous time. The 13.55 days in port include 10.87 days involved in repairs.

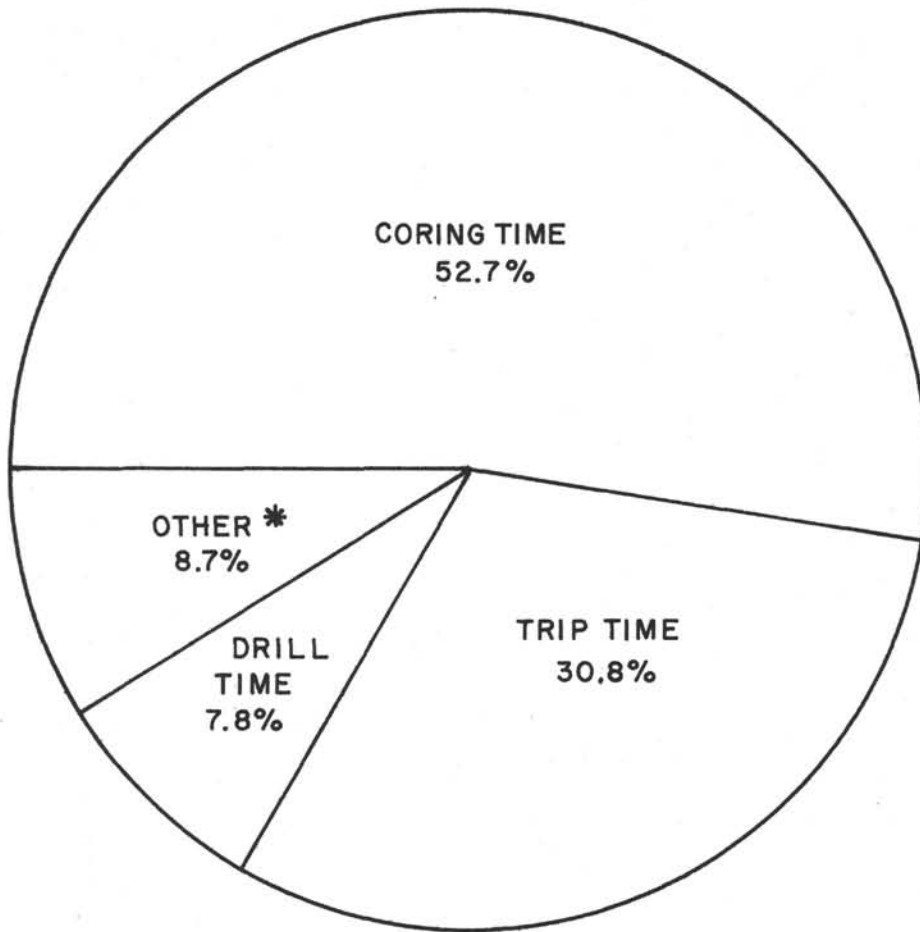
FIGURE 2
DEEP SEA DRILLING PROJECT
TIME DISTRIBUTION
LEG XXXI
ON-SITE TIME

TOTAL LEG TIME: 52.3 DAYS.
TOTAL TIME ON SITE: 32.1 DAYS.
TOTAL SITES: 13.
TOTAL HOLES: 17.

* INCLUDES: WAITING ON WEATHER
HEAT FLOW & INCLINOMETER SURVEYS
SPECIAL HOLE ABANDONMENT OR CONDITIONING
MISC. OTHER ITEMS

Distribution for the 52.3 days total leg time was 61.4% site time, 34.8% cruise time, and 3.8% port time (Figure 1). Total site time of 32.1 days was divided into 52.7% coring, 7.8% drilling, 30.8% trips, and 8.7% other (Figure 2).
