**DEEP SEA DRILLING PROJECT  
TECHNICAL REPORT NO. 11  
OPERATIONS RESUMES - PART VI**

OPERATIONS RESUMES  
LEG 55 through LEG 70

By  
DEEP SEA DRILLING PROJECT  
Scripps Institution of Oceanography  
University of California at San Diego  
March 1980

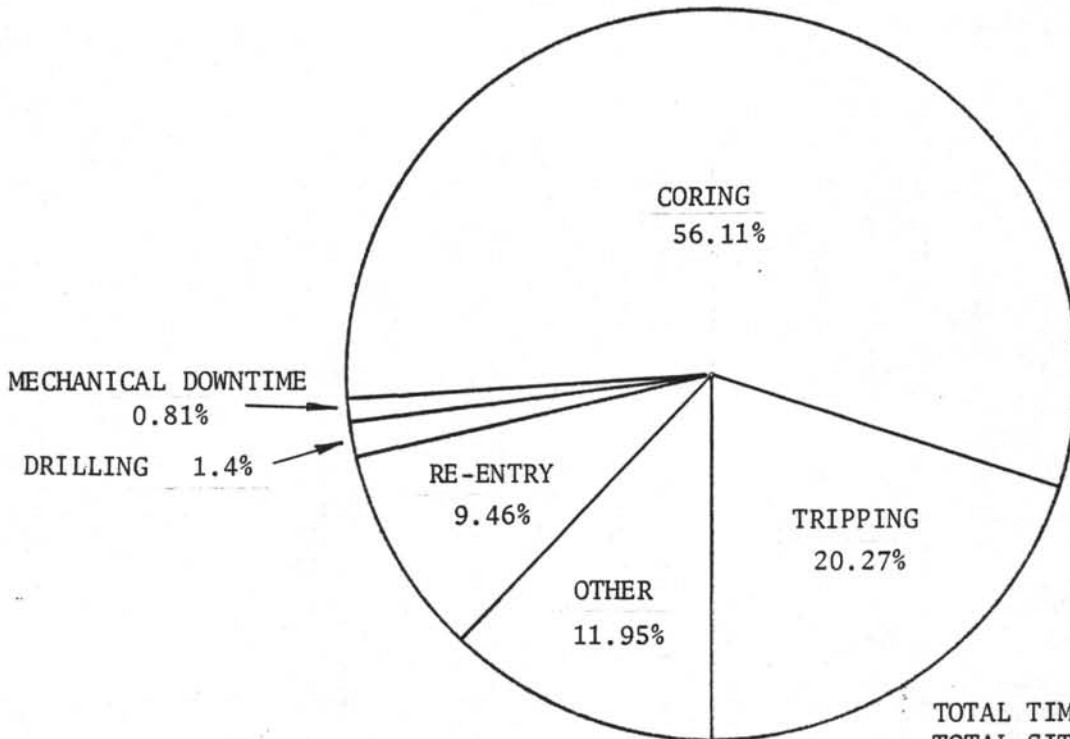
ON-SITE TIME BREAKDOWN

TOTAL TIME ON SITE: 18.5 Days  
 TOTAL SITES: 4  
 TOTAL HOLES: 11
